# Factors Contributing to Poultry House Structural Failures

*Dr. Sid Thompson, Michael Czarick and Dr. John Worley  
Biological and Agricultural Engineering Department*

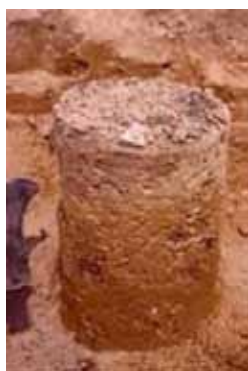
**Figure 1.** Column of soil

A freestanding column of soil such as the one in Figure 1 cannot stand on its own if loaded vertically. While soil can carry a load, a freestanding column of soil fails when loaded. As it fails the column will get shorter and wider. Even though the column of soil is only loaded vertically, lateral (horizontal) forces occur within the soil that make it wider.

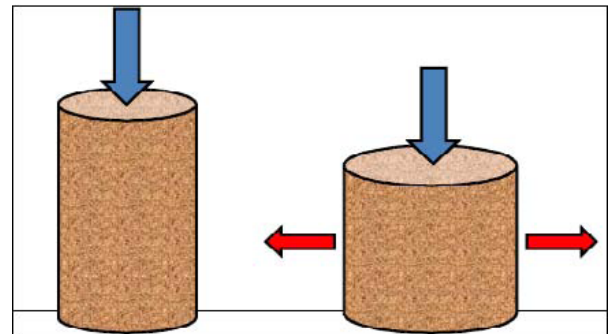
**Figure 2.** Loaded, unsupported soil column

If this same column of soil is placed within a container, then the column can carry a larger vertical load. The container walls keep the soil confined within the container and help carry the lateral (horizontal) loads that occur within the soil.

A building transfers loads throughout the structure to the foundation, which then transfers the load to the soil directly beneath the foundation. Like the column of soil in Figure 2, the soil directly beneath the foundation can only carry these loads if it is properly confined. The confinement in this case does not come from a container but rather from the adjacent soil (Figure 3). It is normally assumed that a triangular block of soil helps confine the soil directly beneath the foundation.

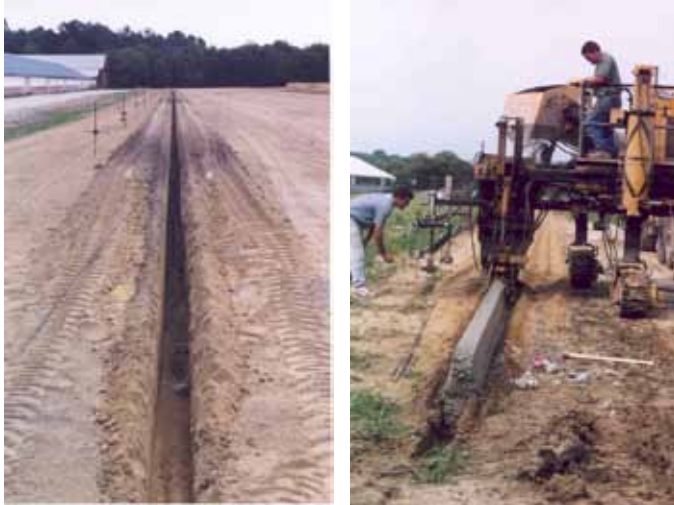
**Figure 4.** Foundation trench

The minimum depth of a poultry house foundation below ground level is generally 12 inches or below the frost line, whichever is greater (Figure 4). The depth of the foundation is measured from the surface of the undisturbed ground to the bottom surface of the foundation. In the case of poultry houses with concrete “stem walls,” the stem wall is the foundation and therefore the bottom of the wall should extend a minimum of 12 inches below the soil surface.

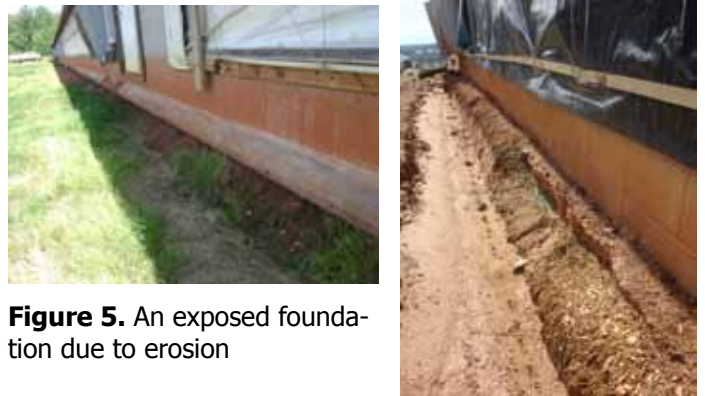
**Figure 5.** An exposed foundation due to erosion

Foundations that are near or above grade can be easily undermined by erosion, rodents or even birds. Once a foundation is undermined the structural integrity of the poultry house is compromised (Figure 5).

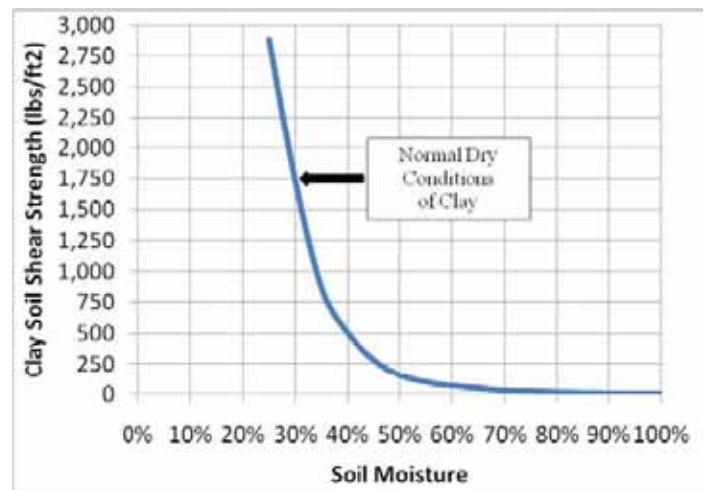
**Figure 6.** Clay soil shear strength as a function of percent moisture

Saturated soil has little strength to support a poultry house foundation in either the vertical or horizontal directions, thus allowing movement. Figure 6 illustrates the shear strength (bearing capacity) of clay soil as a function of percent soil moisture. Under normal moisture conditions, clay soil is capable of supporting a load of roughly 1,800 pounds per square foot. But as clay soil moisture levels increase, the bearing capacity of the ground underneath the foundation decreases rapidly. If the soil in the immediate vicinity of a poultry house is chronically saturated with water, a foundation will be more prone to settling and rotational issues that can lead to a structural failure (Figure 7). As a result, it is important that the soil around a foundation be well drained. Foundation drainage can be aided through the use of foundation drains, permeable soils or rock.

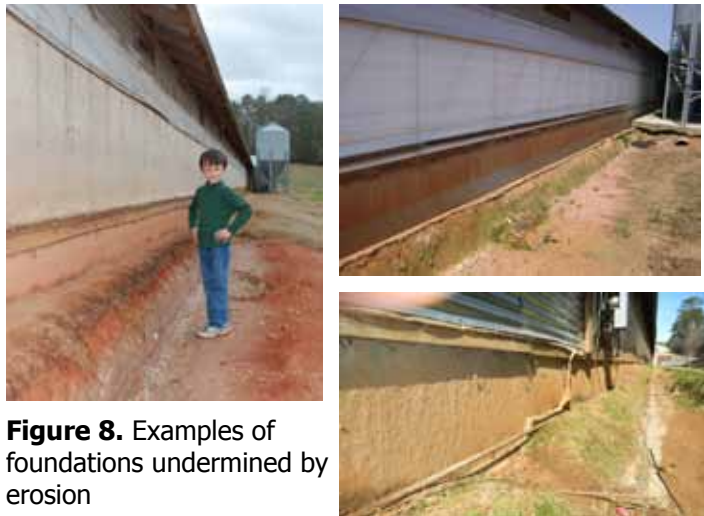
**Figure 8.** Examples of foundations undermined by erosion

The bottom portion of a poultry house foundation must remain covered with soil (Figure 8). The ground around a poultry house should slope gradually (i.e., 1/12) away from the side wall to help direct water from the roof away from the foundation. It is generally recommended that the horizontal distance from the edge of the foundation to the face of any steep slope (3/12+) be a minimum of 5 feet. For steep slopes, rock may be required to prevent erosion.

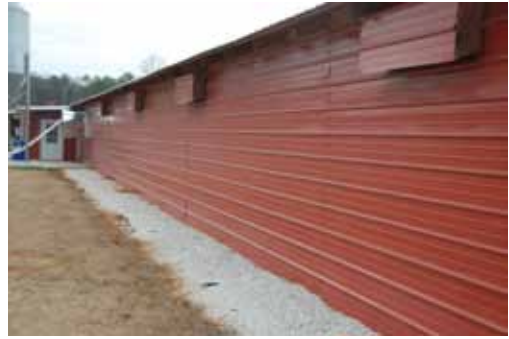
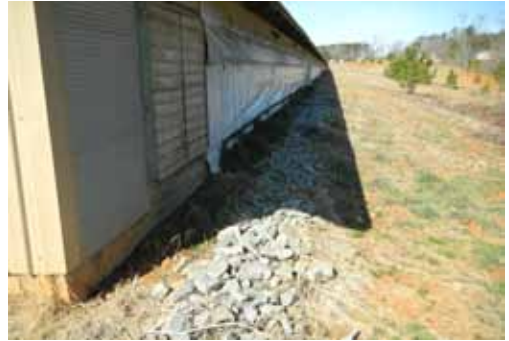
**Figure 9.** Rocks to prevent scouring

The ground in the vicinity of the foundation should be protected from scouring due to rainwater flowing off the roof of the poultry house through the use of vegetative ground cover, rocks or gutters (Figure 9). Over time, scouring can lead to the erosion of soil near the house foundation, thereby effectively reducing foundation depth or possibly undermining the foundation. When scouring has occurred it is important that proper grade is reestablished as soon as possible to prevent foundation movement.

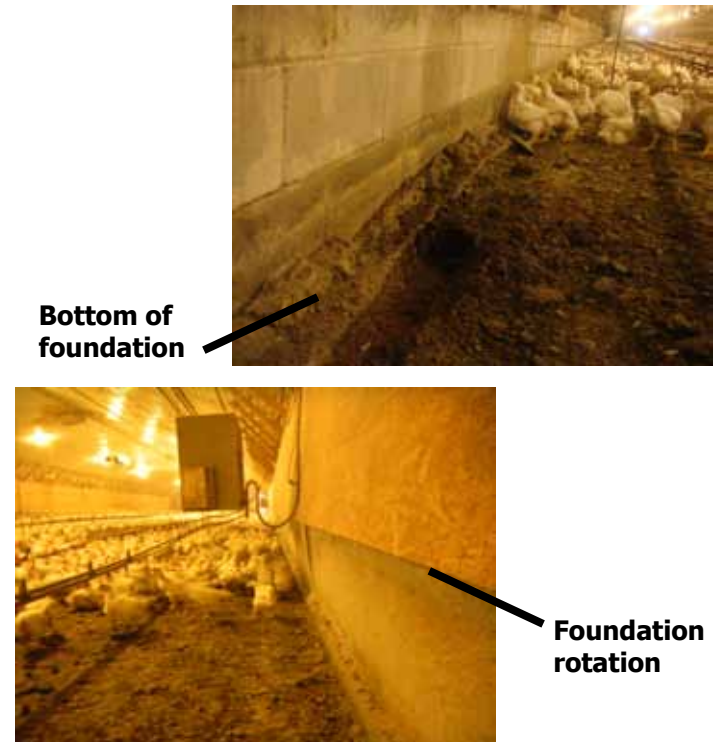
**Figure 10.** Interior Erosion: Soil should be added to maintain structural integrity

An interior foundation depth of 8 to 12 inches must be maintained in order to maintain proper vertical and lateral support. Differences between interior and exterior grades can result in uneven loads being applied to the foundation, which can lead to foundation rotation (Figure 10). When cleaning out, the foundation must be protected from damage and undermining due to excessive soil removal.

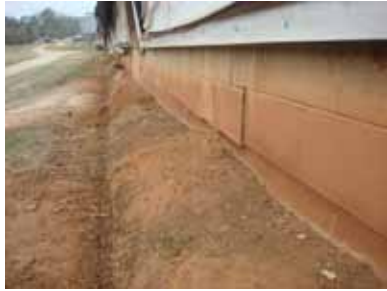
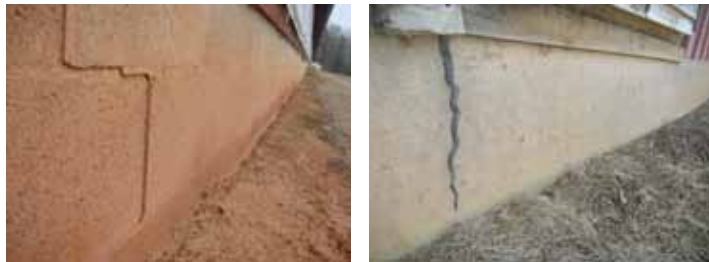
**Figure 11.** Foundation cracking due to rotation/settling

Cracking in a foundation wall is normally a sign of uneven settlement or wall rotation (Figure 11). Settlement is not an adverse characteristic of a structure, provided it is uniform or equal all around the structure and is not excessive. Unequal or differential settlement of a foundation can cause problems in the structure above and can cause it to lean, become unstable or produce large stresses and forces in the members throughout the structure.

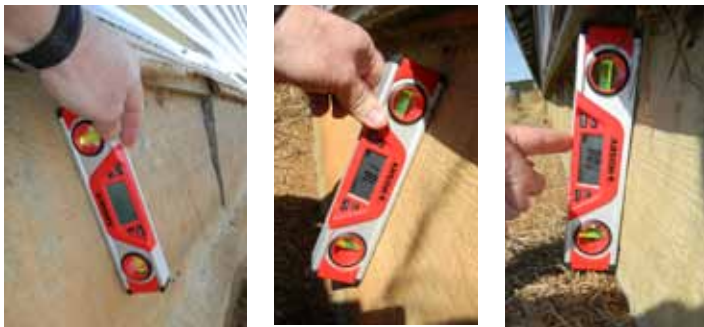
**Figure 12.** Measuring the angle of rotation of a concrete stem wall

Rotation of the foundation wall is normally caused by poor soil conditions – either poor (sandy) underlying soil or poor grading around the structure (Figure 12). The following criterion is suggested:

Rotation of the foundation (degrees)	Suggestion
Less than 5 degrees	Not a major concern
5 to 10 degrees	Concern - Keep wall under watch. Consider adding soil around foundation and/or bracing the wall
Greater than 10 degrees	Structure should be examined by a professional and problems must be corrected

Remember that for a concrete stem wall some slope exists in the side of the walls even with no rotation. To determine how much that built-in slope is, measure the slope near the end wall of the house or at a point where no rotation has taken place, then compare it to the slope at the rotated section.

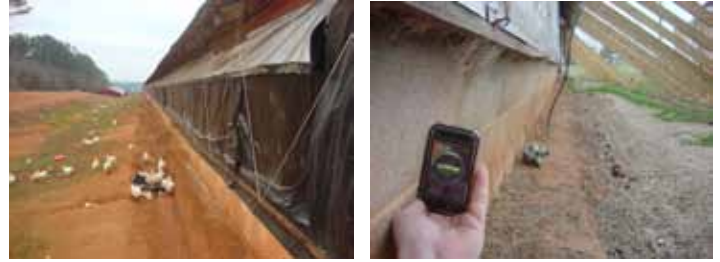
**Figure 13.** Rotation of concrete block wall foundation

For block walls the above-recommended rotation should be reduced if vertical steel was not placed in the wall between courses (Figure 13). Without vertical steel the rotation of the structure is carried only by the mortar joint between block courses (Figure 14).

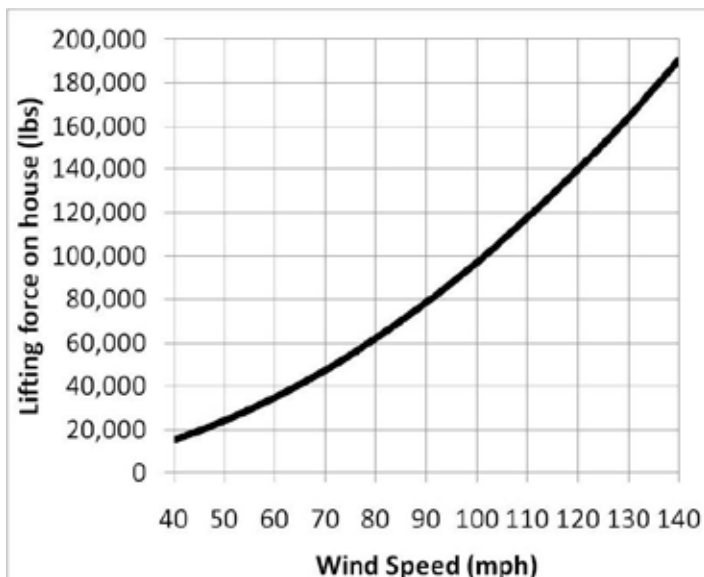
**Figure 15.** Lifting force on a typical 500-foot poultry house as a function of wind speed

High winds moving over a poultry house roof can create powerful lifting forces that can pull the roof from the side walls or the side walls from the foundation. The lifting force on a poultry house is exponentially related to wind speed (Figure 15). That is, a doubling in wind speed can increase the lifting force four fold. For most areas of Georgia, poultry houses are supposed to be built to withstand a 90 to 100 mph wind without failure. For coastal areas the design wind speed is approximately 120 mph.

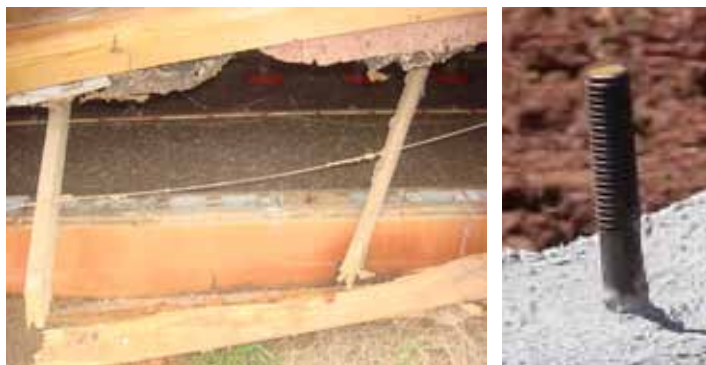
**Figure 16.** Cores of block should be filled intermittently and J-bolts installed to connect plates to the foundation

In order to maintain the structural integrity of a poultry house in high winds it is important that the foundation and side wall act as a single structural unit. Post houses are a prime example of a single structural unit because the post is continuous from the foundation to the eave of the house and acts both as the side wall and the foundation. In the case of houses with concrete blocks, the foundation must be positively connected to the blocks, which in turn must be positively connected to the remainder of the side wall. In houses with concrete stem walls the concrete stem wall must be firmly attached to the wooden portion of the wall. In concrete block wall houses the sill plate should be periodically connected to the foundation through the use of anchor bolts or straps (Figure 16). The anchor bolts or straps must be placed not less than 4 inches and not more than 12 inches from the end of each member making up the sill plate. In concrete stem wall houses, the stem wall is essentially the foundation and as a result the sill plate should be connected to the stem wall through the use of “J bolts” positioned every 8 to 10 feet.

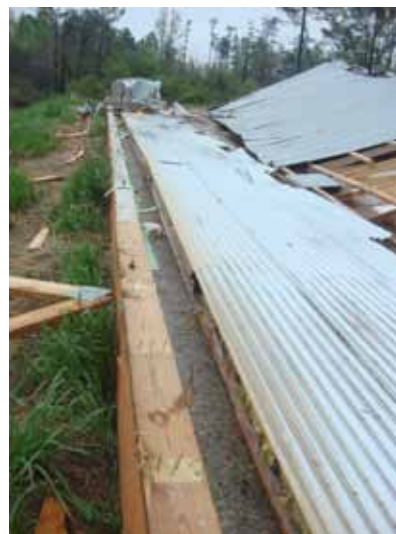
**Figure 17.** Nails loaded in withdrawal allowing pullout

Where wall framing is not continuous from the foundation sill to the roof, members should be tied together to ensure a continuous load path. The vertical members (i.e., sill plate, wall studs, truss plate) in the wall must be positively connected together through the use of lumber, straps or clips. It is important to realize that nails loaded in withdrawal (driven into the end of the studs through the bottom plate) are not sufficient to provide this positive connection in high wind conditions (Figure 17).

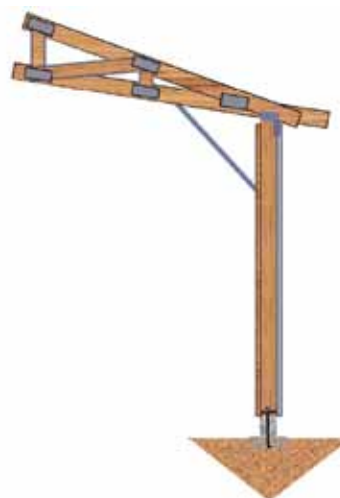
**Figure 18.** Example of side wall with a continuous load path

Figure 18 illustrates an example of a side wall where there is a continuous load path. The sill, block wall and foundation are tied together through the use of a J-bolt and a filled concrete block core. The studs are connected to the sill by the exterior sheet metal and the interior plywood. The truss and the truss plate are tied to the side wall through the use of a “hurricane strap,” thus forming a continuous load path from the truss to the foundation. Figure 19 shows a curtain-sided house where the bottom curtain board/ exterior side wall metal is nailed to both the sill plate and the side wall members, thus tying together the lower portion of the side wall.

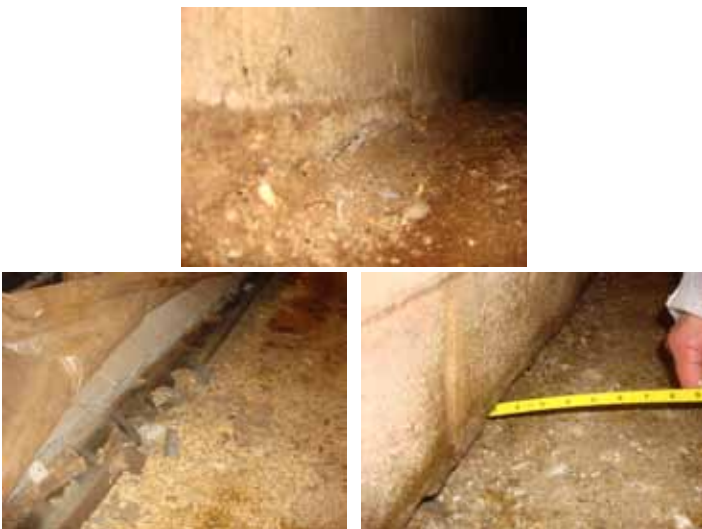
**Figure 20.** Erosion of block caused by manure

Concrete block walls can be degraded by the ammonia in litter. Litter has a higher pH than concrete and also contains salts and moisture. Continuous exposure to manure can reduce the strength of concrete. A precipitate layer forms on the block surface because of the manure, reducing the strength of the blocks and decreasing the cracking strength of the blocks (Figure 20). In some cases the blocks can be eroded by the presence of the litter against the block wall. Block wall foundations must be inspected for erosion of the block. If sufficient damage to the block wall occurs, then the block wall must be replaced or repaired.

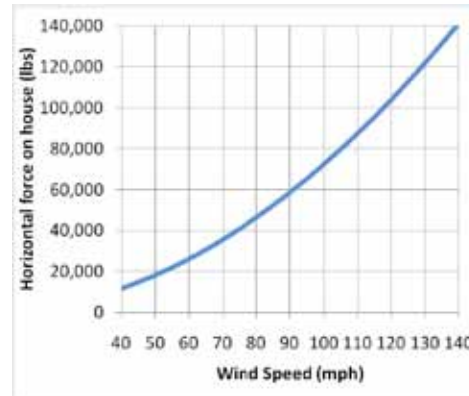
**Figure 21.** Horizontal force on a typical 500-foot poultry house as a function of wind speed

In addition to lifting forces, winds can also generate lateral forces that can push a house over. The lateral wind loads, like the lifting loads, increase exponentially with wind speed. A 40 mph gust can generate 10,000 pounds of force trying to push a poultry house over (Figure 21). In a poultry house, lateral forces are transmitted down through the truss to the walls and then the foundation through the use of knee braces (Figure 22). The knee braces eliminate rotation at

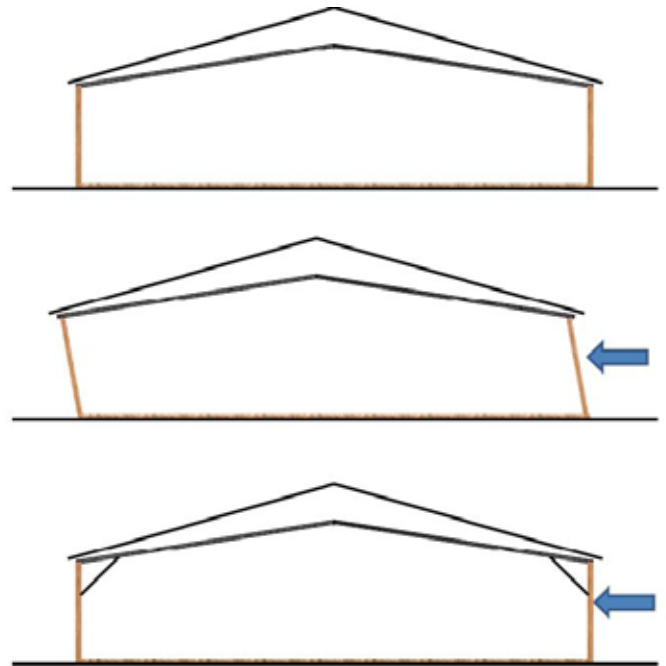
**Figure 22.** Knee braces provide support to resist sideways movement

the truss to wall connection points and increase the ability of the wall section to carry vertical loads. The knee braces are needed to prevent excessive lateral movement. While knee braces may not be required on each truss, knee braces must extend over much of the house to carry these loads.

The truss wall system of a poultry house is an unstable mechanism without such bracing. Without this type of bracing, the walls of a poultry house are not built to withstand the lateral forces caused by winds.

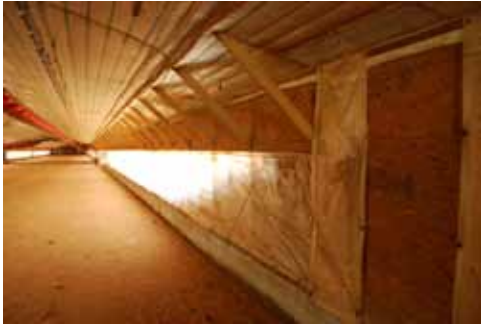
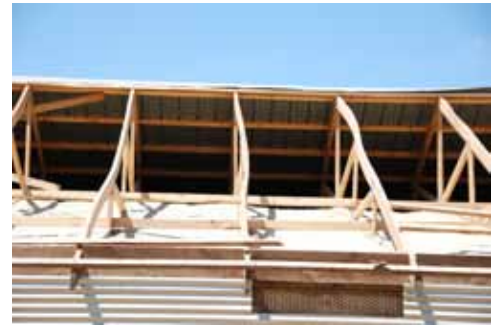
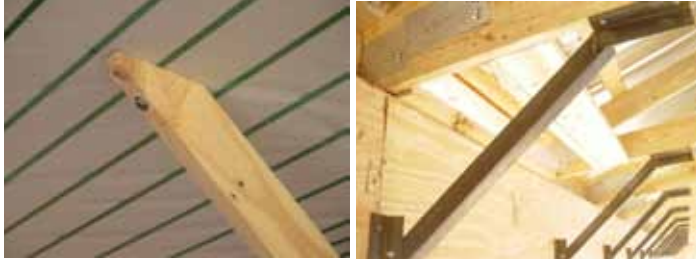
**Figure 23.** Knee braces

Knee braces must be of sufficient size to carry the loads from the truss to the wall. Normally this might be 2x4 members or 1 ½ inch x 1 ½ inch angle iron. The connection between the knee brace and wall must be sufficient to transfer this load. It is recommended that lag bolts be used to make this connection (Figure 23).

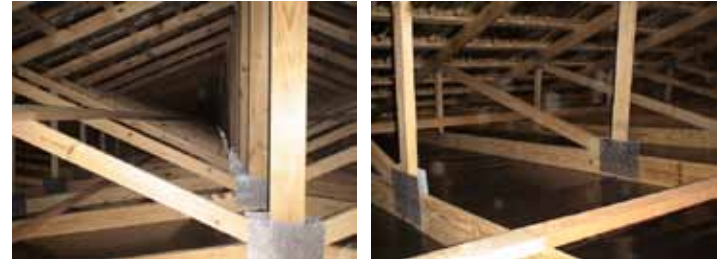
**Figure 25.** Bracing of trusses is essential to keep trusses vertical and to help carry loads along the length of the house

1. The connector plates should be located on both faces of the truss.
2. The nails should be fully embedded in the member.
3. The members should be cut for tight-fitting wood-to-wood bearing at the joints.
4. The trusses must be braced such that they remain in a straight and plumb position (Figure 25).
5. Trusses must be handled with care during banding, bundling, delivery and installation to avoid damage.

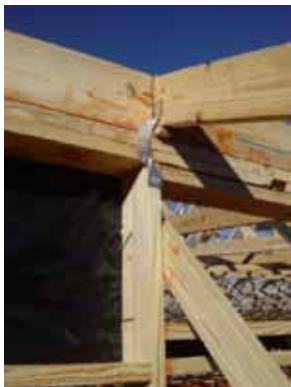
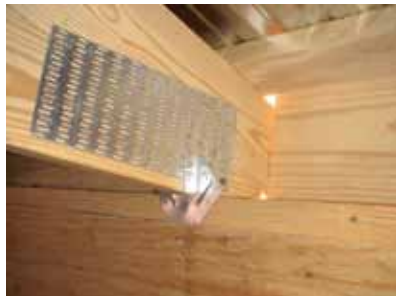
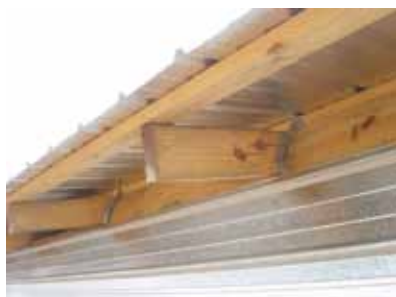
**Figure 24.** Trusses tied to the top of a wall using "hurricane straps"

The truss must be positively connected to the wall to prevent problems during up-lift caused by wind loads. Where wall framing is not continuous from the foundation to the roof, the members must be secured to ensure a continuous load path. The truss must be positively connected to the wall by straps, clips or connectors made of corrosion-resistant material not less than 0.040 inch in thickness (18 to 20 gage) (Figure 24). Nails loaded in withdrawal are not sufficient to provide this positive connection in high wind conditions.

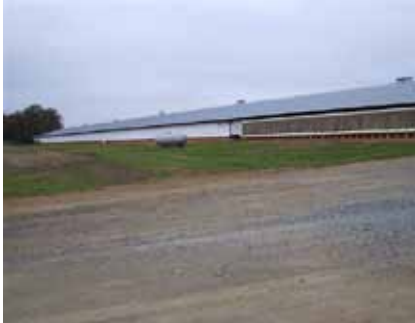
**Figure 26.** Poultry house with straight ridge line

The roof line should be straight and horizontal inside and outside (Figure 26). From visual inspection of the house, if the roof line is not horizontal then a detailed inspection of the trusses and house must occur in the region of the house where this settlement has occurred (Figure 27). In that region the trusses must be inspected for straightness as well as any problems associated with truss plates, twisting

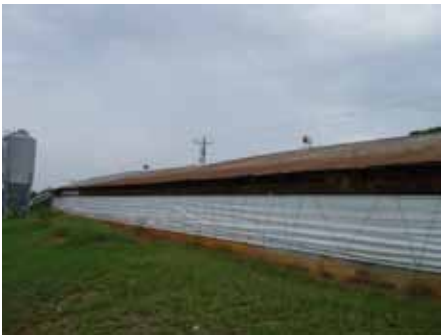
**Figure 27.** Poultry house with possible truss damage

of members, etc. The region to be inspected must extend a sufficient distance in both directions from the point where settlement has occurred to make sure no additional problems exist. Knee braces must be added in that region of the house if they are not already provided. If, during truss inspection, truss plates are found to be pulling out of the wood, trusses should be repaired using plywood gusset plates on both sides of the truss at the joint having problems. The roof should be inspected to make sure all the roof metal is adequately attached to the purlins and that no leaks occur in the roof. No sagging should be observed in the roof between trusses.
