Poultry Housing Tips

Potential Problems with Blown Insulation in Dropped-Ceiling Houses

Volume 17 Number 4

March, 2005

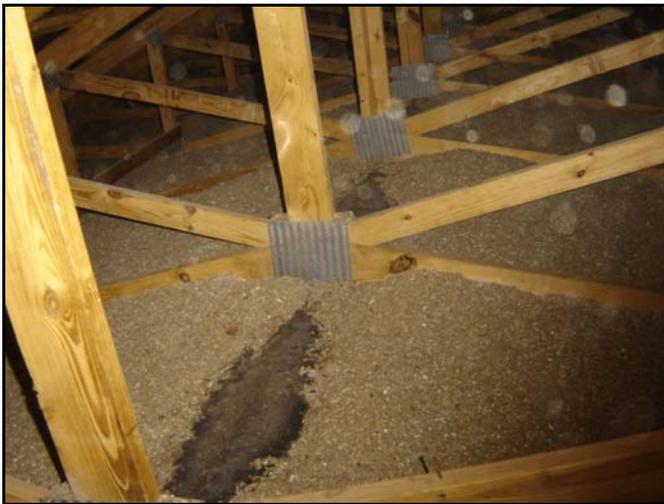
Figure 1. Missing blown ceiling insulation.

There are a number of possible causes of the lack of insulation near the peak and side walls of a dropped ceiling house. First, exhaust fans turning on and off tend to pulse the ceiling a little which over time can tend to shake the insulation down toward the side wall (Figure 1). Secondly, strong winds can also shift cellulose insulation, especially if the eaves are not closed sufficiently (Figure 2). Last but not least, insufficient amounts of insulating material may have been blown in originally or was simply not blown in uniformly.

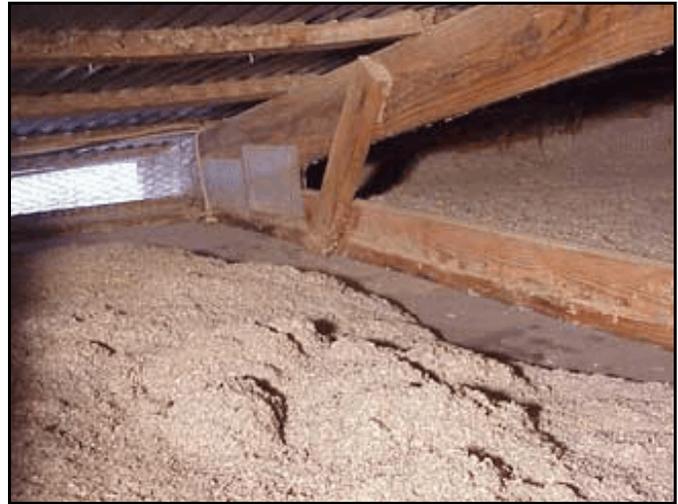
Figure 2. Missing ceiling insulation near side wall
