# Poultry Housing Tips

## *A New Method of Totally-Enclosing Curtain-sided Houses*

Volume 18 Number 1

January, 2006

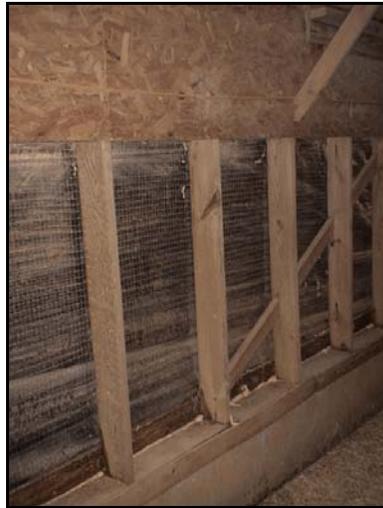
Figure 1. Side wall - before

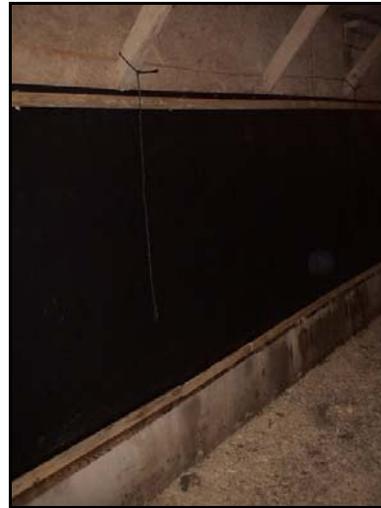
Figure 2. Side wall - after

that it overlaps the curtain opening a couple of inches at the top and bottom. 1" X 2" wood strips are then used to attach the insulation to the side wall above and below the curtain opening (Figures 2 and 3). Additional vertical wood strips are then typically installed every 10' to 15' for added support. In most instances, installation takes less than a day.

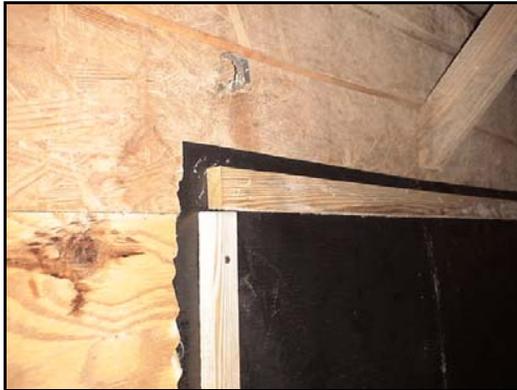
Figure 3. 1" X 2" wood strips securing Therm-All to side wall.

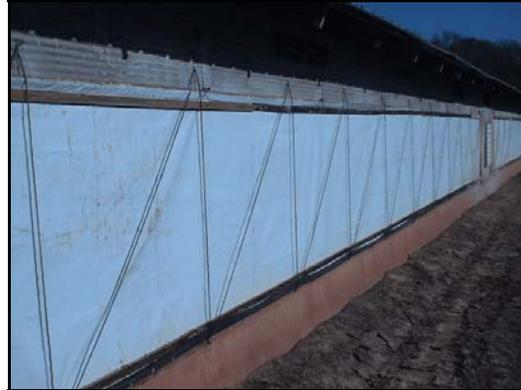
Figure 4. Side wall curtain sealed using 1" X 2" wood strips.

Installation is fairly straightforward. In a traditional stud-wall house the side wall curtains are sealed at the top and bottom using 1" X 2" wood strips (Figure 4). The insulation is then rolled over the inside surface of the stud wall so

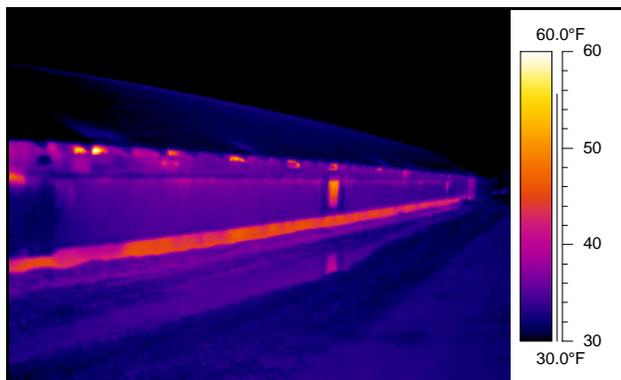
Figure 5. Thermal image of exterior of the house insulated with Therm-All insulation.

The thermal images shown in Figures 5 and 6 were taken on a December morning just after the chicks were placed and illustrate just how effective the Therm-All insulation was in reducing heat loss from a poultry house. Temperature inside the houses was approximately 90°F while outside it was in the low thirties. The exterior surface temperature of the curtain in the house where the Therm-All insulation was installed was in the mid thirties indicating very little heat loss from the curtain portion of the side wall. In fact, the surface temperature of the curtain portion of the side wall was essentially identical to the side wall above the curtain opening that is constructed of plywood, fiberglass, and metal, indicating that the insulation value of the curtain area was essentially the same as the wall above it.

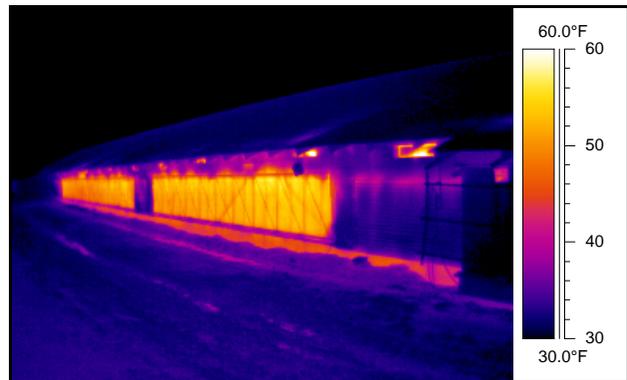
Figure 6. Thermal image of exterior of the house with traditional side wall curtain.

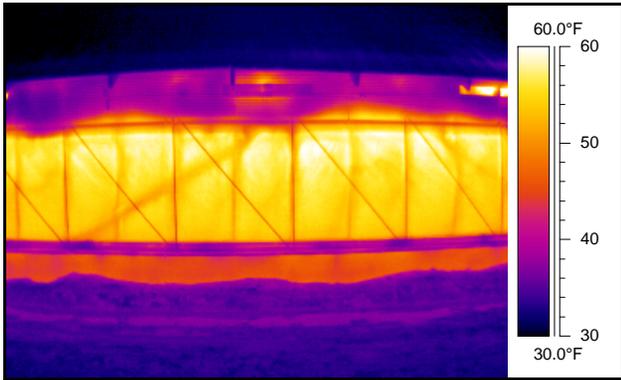
Figure 7. Hot air leaking from top of the side wall curtain.

The thermal image of the side wall of the house that wasn't enclosed is dramatically different than the enclosed house. The exterior surface temperature of the curtain was in the mid-fifties indicating significant heat loss through the curtain. Making matters worse was the fact that there was a significant amount of hot air leaving the house from the top of the side wall curtain which can be clearly seen in Figure 7.

Though an overall fuel savings of 25% is significant, it is not quite as high as noted on other farms after they were totally enclosed. In addition to the problems noted previously, the fact that the house was built with a concrete stem wall could have reduced potential fuel savings. Figures 7 and 8 show that the exterior surface temperature of the concrete was not that much different than the uninsulated side wall curtains, indicating that the insulation value of the concrete stem wall is not that different than a curtain. So though heat loss from the curtain was significantly decreased, the stem wall which was almost half the size of the side wall curtain was left uninsulated. Furthermore, the joint between the concrete stem wall and stud wall was a significant source of air leakage. Though it was a potential problem area in both houses, in the totally enclosed house leakage was increased due to the fact that timer fans generated significantly higher static pressure in the house that was totally enclosed, which increased leakage from this crack, which further decreased floor temperatures in the vicinity of the concrete stem walls (Figures 11, 12 and 13). The issue of air leaking from the joint was often noted by the observation of birds acting chilled near the side wall in the house that was totally enclosed.

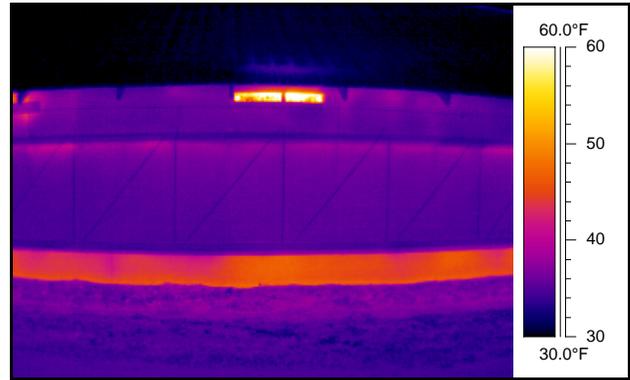
Figure 8. House insulated with Therm-All insulation.

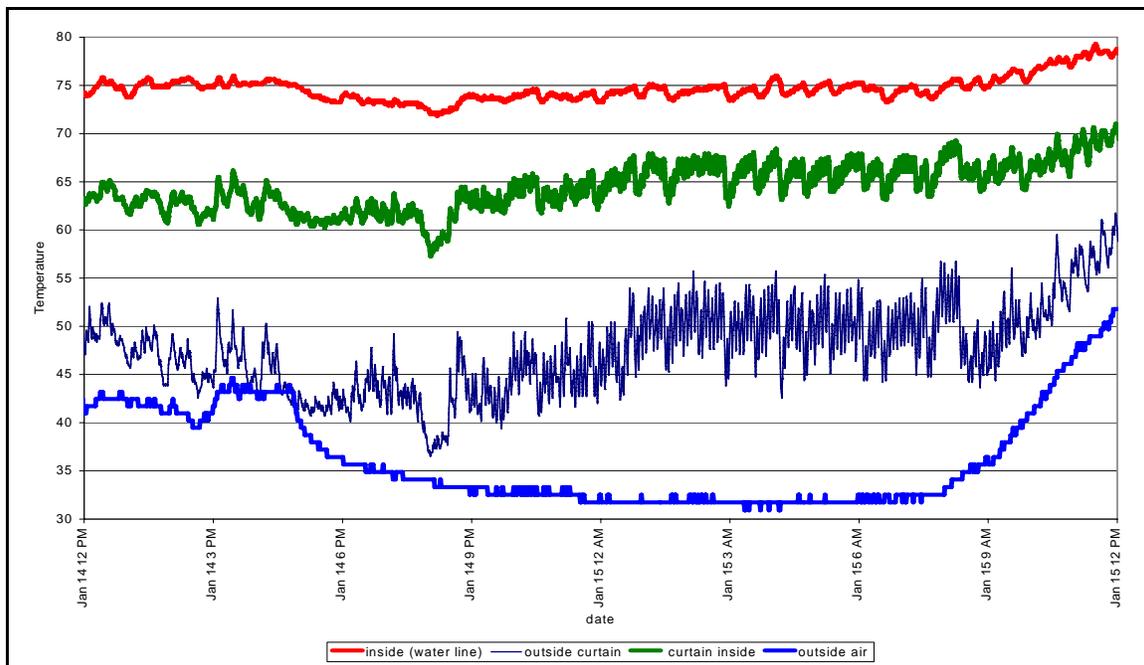
Figure 9. Temperature graphs for the control house.

When the birds were approximately four weeks old, temperature data loggers were placed inside and outside the houses to better document heat loss from the side walls of both houses. Dataloggers were placed just above the side wall curtain outside each house, inside both houses near the bottom of the curtain opening, on one of the outside water lines in each house as well as under the roof overhang on one of the houses to obtain outside air temperature. The graphs

in Figures 9 and 10 are for one 24-hour period which is fairly representative of the temperatures seen during the two weeks the dataloggers were used.

For the totally enclosed house the temperature of the air above the outside curtain is essentially the same as the air temperature measured under the eave, indicating little or no hot air was escaping from the sealed curtain (Figure 10). The higher outside air temperatures measured just above the closed side wall curtains of the control house show that a significant amount of hot air was lost from the house especially at night (Figure 9). The jagged nature of the line is an indicator of the timer fans operating. When the fans were off, the air temperature rose above the loose-fitting curtain as warm air leaked from the house. When the timer fans turned on, warm air would no longer exit the house and the air temperature just above the curtain opening would decrease. The inside air temperature at the bottom of the curtain opening of the control house was noticeably cooler than at the same location in the house where the Therm-All insulation was installed, indicating cool air leaking into the house (Figures 9 and 10). Air temperature measured at the water line was just slightly warmer in the house where the Therm-All insulation was installed (Figures 9 and 10).

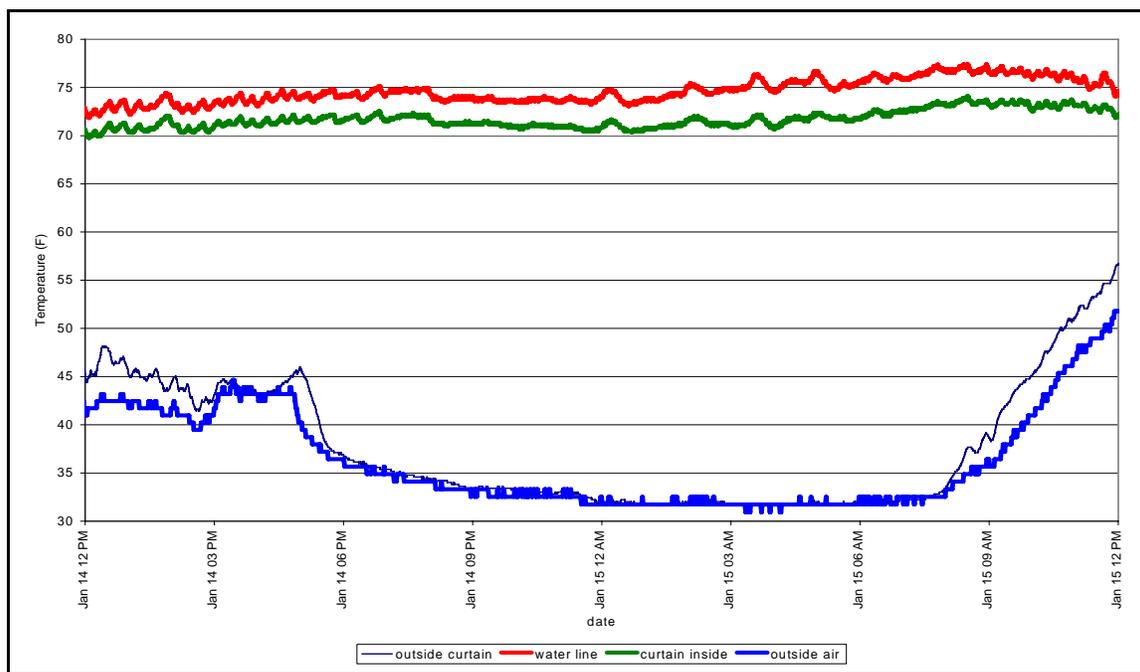
Figure 10. Temperature graph for the treatment house.

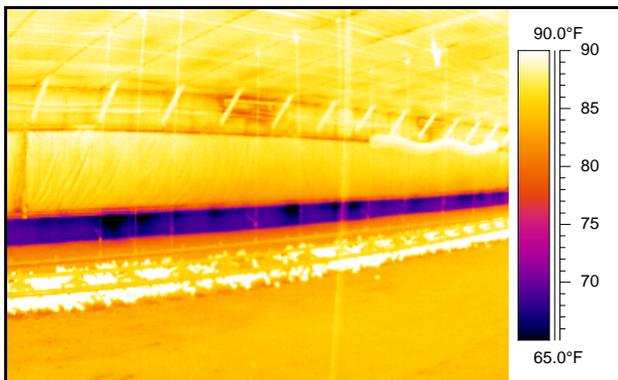
Figure 11. Leakage from crack between stem and stud walls indicated by dark blue streaks.

The problem of the air leakage from the crack between the stem and stud walls was made worse by the fact that the house was heated using forced air furnaces without circulation fans. Had the house been equipped with circulation fans the hot air from the ceiling could have been moved down to floor level helping to offset the cold air leaking in through the crack in the lower side wall. Though the circulation fans would have not helped the two situations of increased heat loss due to the low insulation value of the concrete stem wall and the crack between the stem and stud walls, at least the birds would have likely been more comfortable near the side wall, and fuel usage would have been reduced as the hot air produced by the forced air furnaces would have been better utilized.

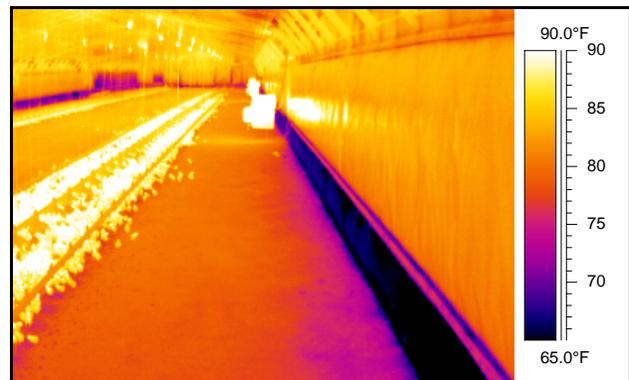
Figure 12. Low floor temperatures near concrete stem wall.

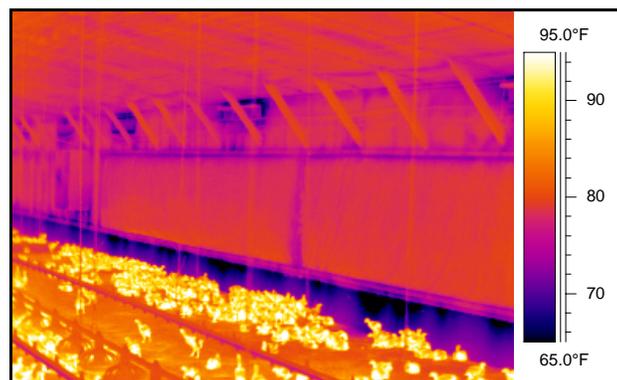
Figure 13. Leakage from crack between stem and stud walls (three-week-old birds).

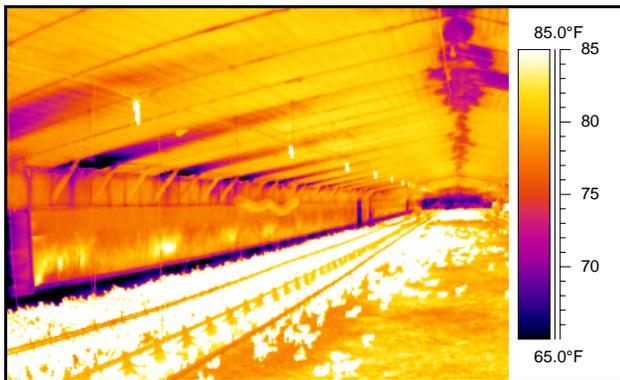
Figure 14. Thermal image of a totally enclosed house with galvanized ceiling inlets on the test farm.

One last problem with the houses that may have affected the potential fuel savings was that the houses had small 4' X 4" wooden inlets. Inlets are important in any broiler house, but having good inlets is more critical in tight houses. The inlets in these houses did not do a good job of throwing air to the center of the house when compared to more conventional metal inlets in other houses on the farm. The thermal image in Figure 14 was taken in another house on the farm that was totally enclosed using reflective insulation (a subject to be covered in a future newsletter) that was equipped with galvanized ceiling inlets. The dark blue streaks starting at the inlets and fading toward the center of the house are an indicator that the air entering through the inlets is making it more or less to the center of the house (the blue areas in the center of the houses are indications that there is missing ceiling insulation). In contrast the air entering through the wooden inlets in the house is not being thrown nearly as well to the center of the house (Figure 15). Since the cold incoming air was not being mixed as well with the hot air near the ceiling this could result in draftier conditions and increased fuel usage.

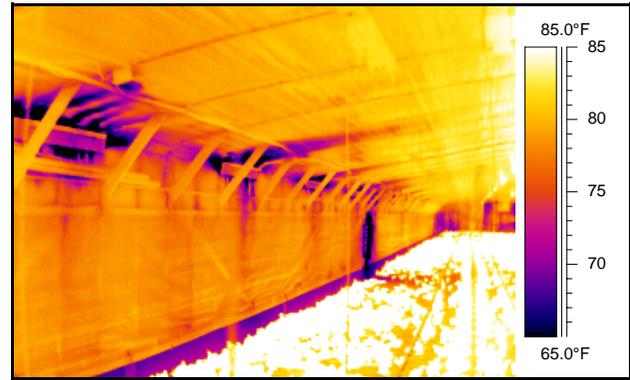
Figure 15. Thermal image of totally enclosed house with small wooden inlets.
