Poultry Housing Tips

Blown Stabilized Fiberglass Insulation

Volume 21 Number 1

January, 2009

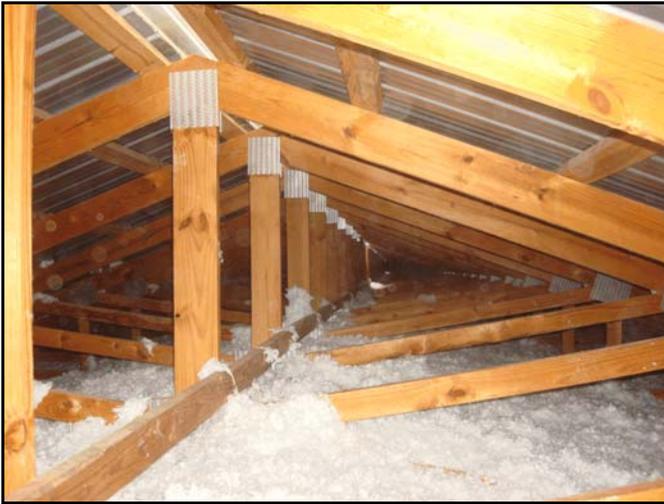
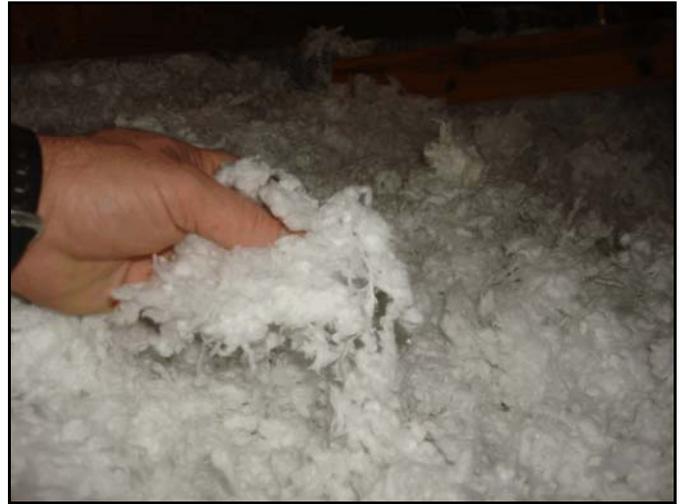
Figure 1. Blown stabilized fiberglass insulation.

Three of the houses on the farm were reinsulated with blown stabilized fiberglass insulation to bring the total level of insulation even with the top of the bottom 2" X 6" cord of the truss (Figure 1). Though the blown stabilized fiberglass insulation did not form a solid matt of insulation, it did appear to bind together better than traditional blown cellulose insulation. Thermal images taken of the houses after the addition of the blown fiberglass insulation confirmed the fact that the blown insulation had significantly reduced heat loss through the ceiling (Figure 4). The producer reported that propane usage of the three houses that were reinsulated with the blown stabilized fiberglass insulation was 20% lower compared to the houses which were not reinsulated.

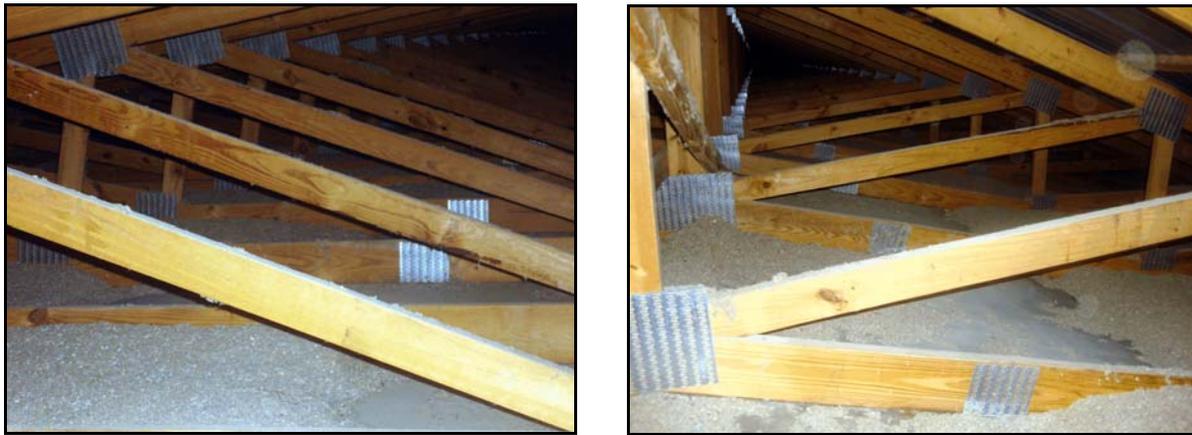
Figure 2. Missing ceiling insulation.

Recently a study of stabilized fiberglass insulation, manufactured by Guardian Building Products (800-968-8265) was initiated at a six house farm with a severe problem with shifting cellulose insulation (Figure 2). Large areas of insulation were missing from near the peak of the ceiling as well as in spots over the feed lines of all six houses on the farm (Figure 3). Not only did the producer feel that the lack of proper ceiling insulation was affecting his heating costs but during cold weather condensation would form on the uninsulated areas of the ceiling and drip onto the floor causing wet spots. The severity of the problem was likely caused by the fact that the cellulose insulation was not blown to the minimum recommended depth of five inches when the houses were built seven years ago as well as due to the fact that 24" circulation fans were used to mix the air in the house during cold weather which were often directed up towards the ceiling causing significant ceiling vibration.
