Poultry Housing Tips

Blown Stabilized Fiberglass Vs. Blown Cellulose Insulation...2 ½ Years Post Installation

Volume 23 Number 1

January, 2011

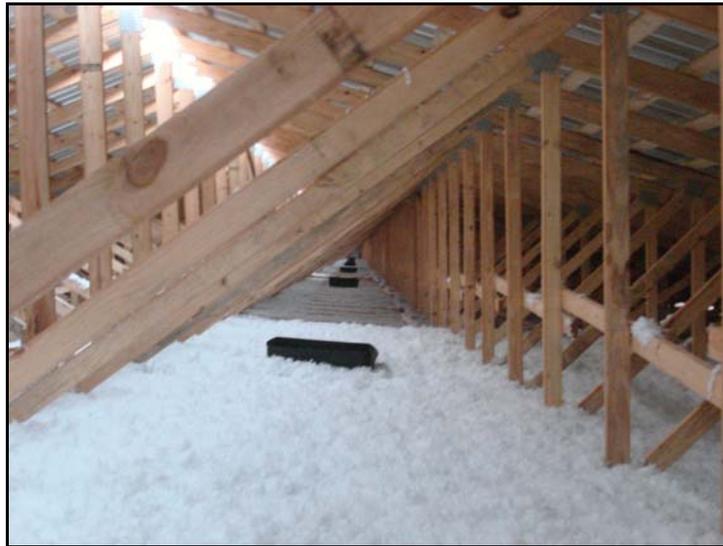
Figure 1. Blown stabilized fiberglass (foreground) and blown cellulose insulation (background)

In August of 2008 a study was initiated to compare the long term integrity of blown stabilized fiberglass insulation (Stable R[®], Guardian Building Products[®]) to traditional blown cellulose insulation (Figure 1). Stabilized fiberglass insulation is a fiberglass insulation product with special binders that causes the fiberglass insulation to tend to stick together after it is installed (see the January, 2009 edition of *Poultry Housing Tips*). Since blown stabilized fiberglass insulation was developed for use in ceilings in residential houses with slopes as high as 45 degrees, it was hoped that it would be less prone to settling and shifting problems sometimes seen in houses insulated with traditional blown cellulose insulation. The study is being conducted in a recently constructed 66' X 600' broiler house. 500 feet of the ceiling of the study house was insulated using approximately six inches of traditional blown cellulose insulation (to the top of the 2" X 6" bottom cord of the roof truss, R-value = 20 ft²*hr/Btu's). To help prevent the shifting of insulation away from the ceiling peak, a six foot long piece of six-inch thick fiberglass batt was placed along the ceiling peak then covered with a thin layer of blown cellulose insulation. Towards the center of the house, a 100' section of ceiling was insulated solely with eight to nine inches of blown stabilized fiberglass insulation (R-value = 26 ft²*hr/Btu's, Figure 4).

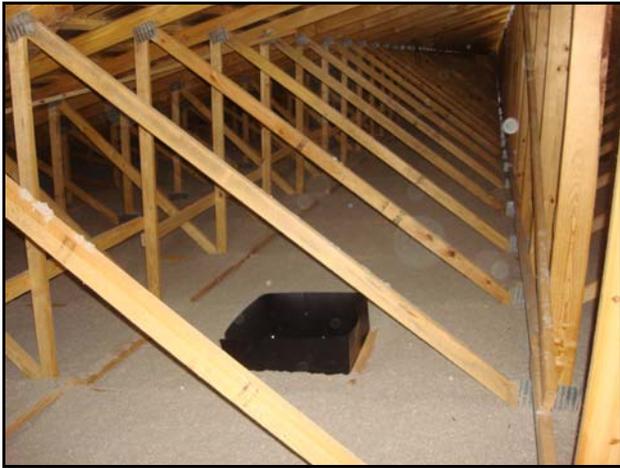
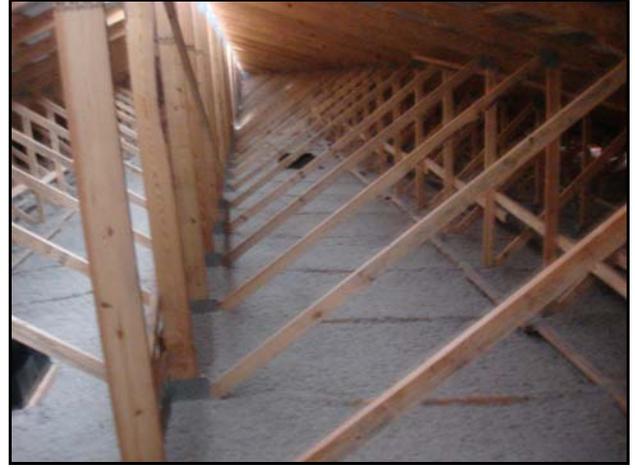
In February of 2009, approximately six months after the installation of the blown fiberglass and cellulose insulation products, the farm was visited to note any changes that had taken place since installation. While no significant changes were found in the portion of the ceiling insulated with the blown stabilized fiberglass insulation, the depth of the blown cellulose insulation had decreased between ½" to 1" (Figure 2).

Figure 2. Blown cellulose insulation (January, 2009. Six months after installation)

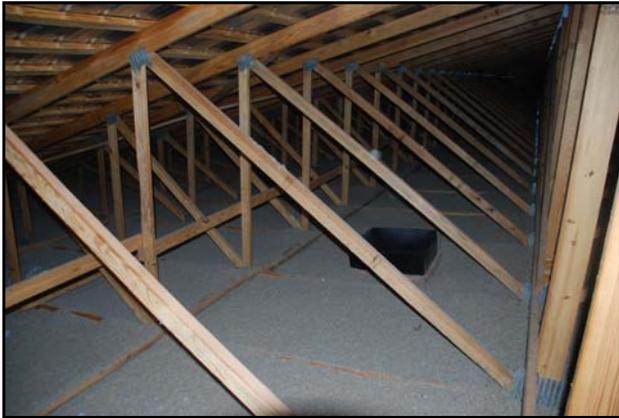
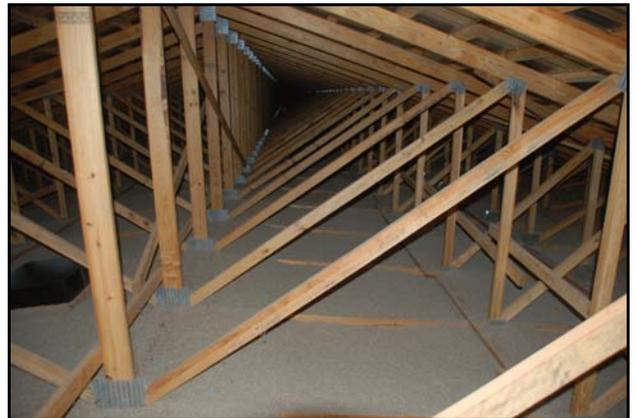
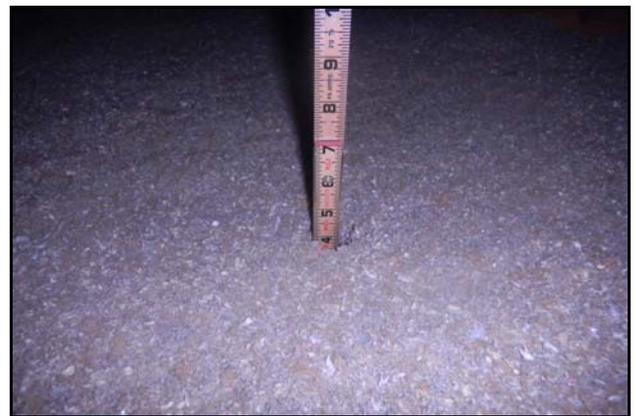
In February of 2011 the farm was visited once again to document any changes that had taken place since the ceiling was insulated. Though there were no significant changes in the stabilized fiberglass insulation, the depth of the blown cellulose insulation had decreased between one and two inches since installation (There were some isolated areas of the ceiling, near the eaves, where the reduction in depth was closer to three inches - Figure 5). It is important to note that what appeared to be settling near the eaves may be in part due to the movement of insulation caused by increased air velocities that generally occur in this area of the attic on windy days and the fact that the original insulation depth was slightly less due to difficulties involved in blowing insulation near the eaves of a house. In general, what was originally a ceiling with a R-value of 20 ft²*hr/Btu's (5 1/2" blown cellulose) after two and a half years had decreased to one with a R-value of 15 ft²*hr/Btu's (4" blown cellulose).

Figure 3. Blown cellulose insulation (February, 2011. Two years, six months after installation)

Though the study comparing stabilized blown fiberglass to blown cellulose insulation is far from over, results to this point confirm the DOE recommendation that when using blown cellulose insulation, installers should take into account the fact that the insulation will settle approximately 20% over time (compared to 2 to 4 percent for fiberglass). Settling may be greater, as observed in this study, in poultry houses due in part to the movement of the dropped ceilings as fans turn on and off.

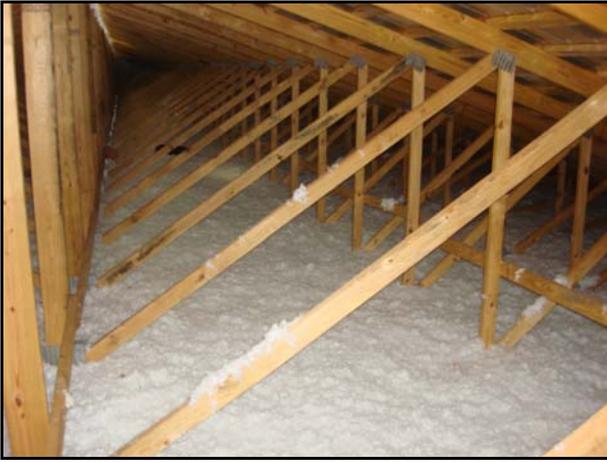
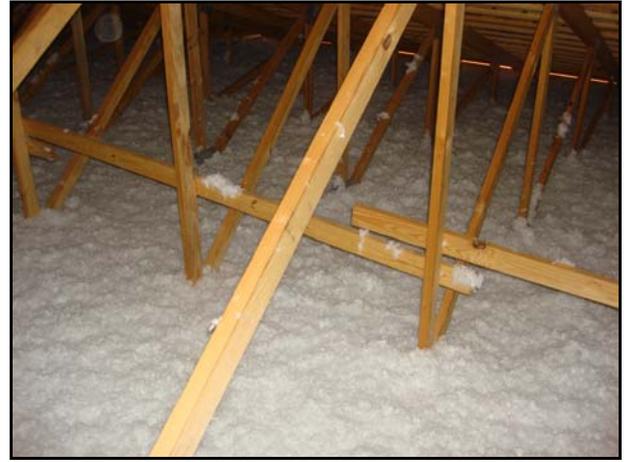
Figure 4. Blown stabilized fiberglass insulation (January, 2009. Three months after installation)

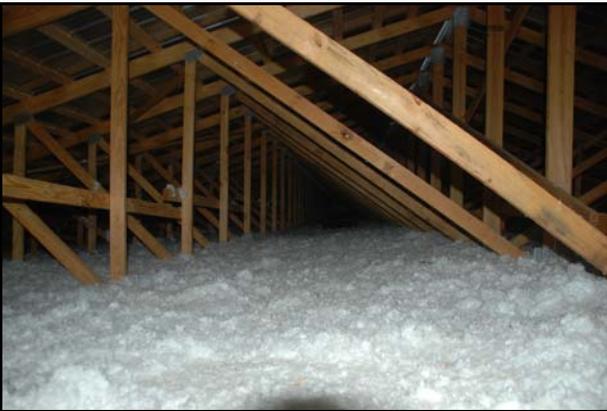
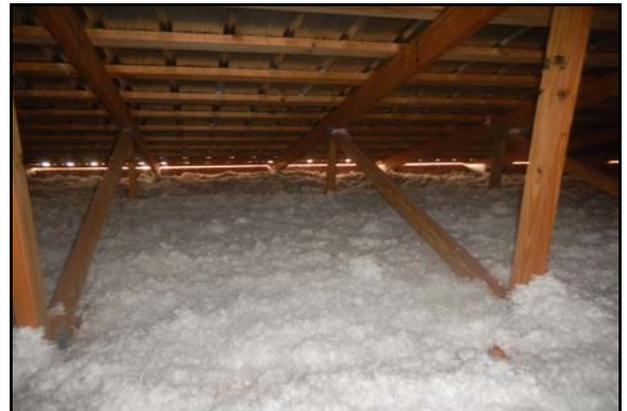
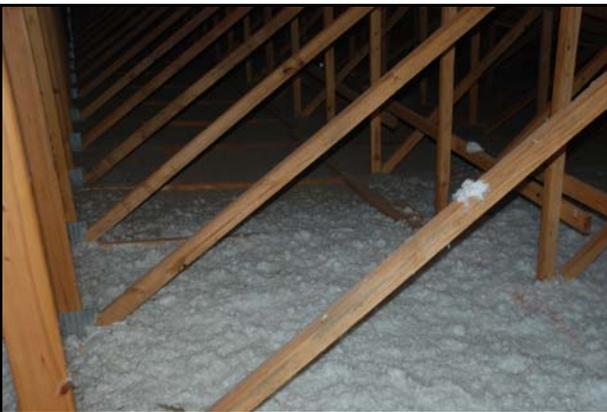
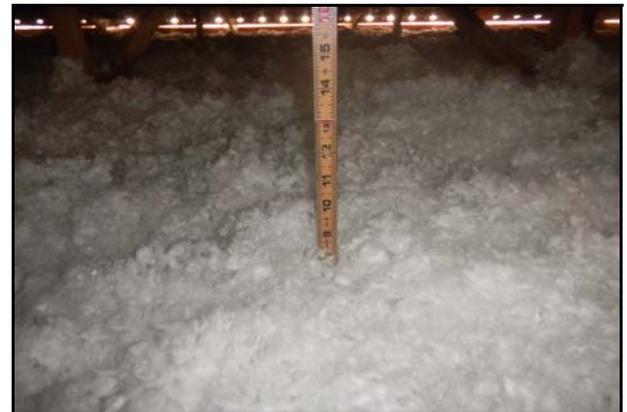
Figure 5. Blown stabilized fiberglass insulation (February, 2011. Two years and four months after installation)
