Poultry Housing Tips

Blown Stabilized Fiberglass Vs. Blown Cellulose Insulation...7 Years Post Installation

Volume 27 Number 8

2015

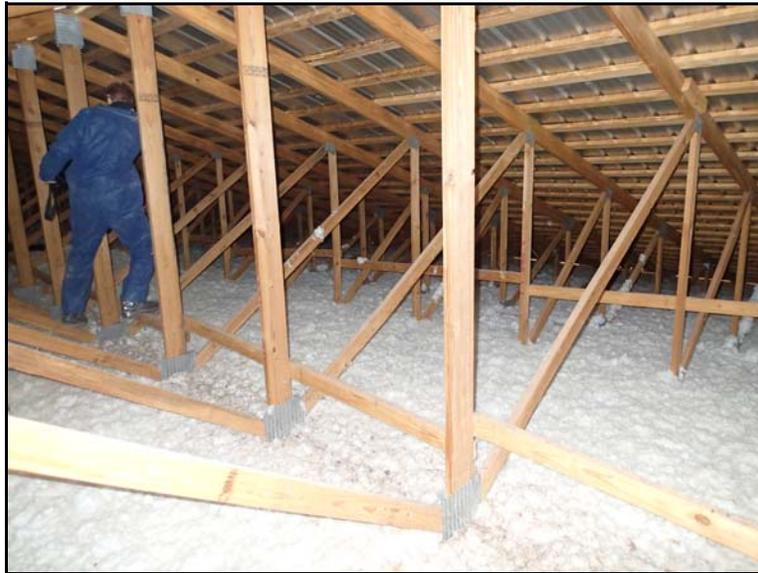
In August of 2008 a study was initiated to compare the long-term integrity of blown stabilized fiberglass insulation to traditional blown cellulose insulation (Figure 1). Stabilized fiberglass insulation is a product with special binders that cause the fiberglass insulation to stick together after it is installed (see the January, 2009 edition of *Poultry Housing Tips*). Since blown stabilized fiberglass insulation was developed for use in ceilings in residential houses with slopes as high as 45 degrees, it was hoped that it would be less prone to settling and shifting problems sometimes seen in poultry houses insulated with traditional blown cellulose insulation. The study was conducted in a newly constructed 66' X 600' broiler house. 500 feet of the ceiling of the study house was insulated using approximately six inches of traditional blown cellulose insulation (to the top of the 2" X 6" bottom cord of the roof truss, R-value = 20 ft²*hr/Btu's). To help prevent the shifting of insulation away from the ceiling peak, a six-foot-long piece of six-inch thick fiberglass batt was placed along the ceiling peak then covered with a thin layer of blown cellulose insulation. Towards the center of the house, a 100' section of ceiling was insulated solely with eight to nine inches of the stabilized fiberglass insulation (R-value = 24 ft²*hr/Btu's).

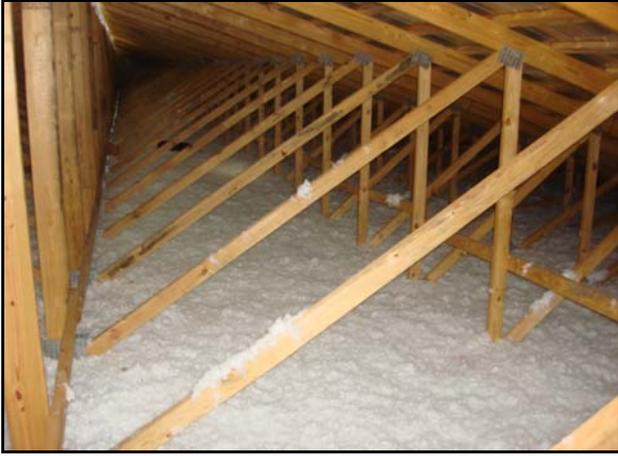
Figure 2. Blown stabilized fiberglass (6 months)

In February of 2009, approximately six months after the installation of the blown fiberglass and cellulose insulation products, the broiler house was examined to note any changes that had taken place since installation. While no significant changes were found in the portion of the ceiling insulated with the blown stabilized fiberglass insulation (Figure 2), the depth of the blown cellulose insulation had decreased between ½" to 1" (Figure 3).

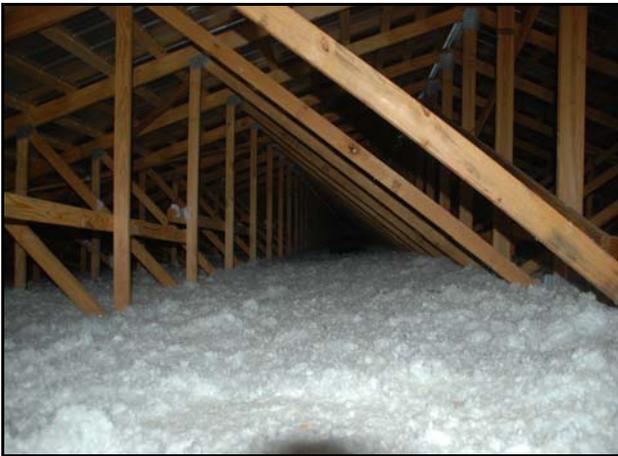
Figure 4. Blown stabilized fiberglass (2 ½ years)

In February of 2011, the farm was visited again to determine any changes that had taken place since the ceiling was insulated. Though there were no significant changes in the stabilized fiberglass insulation, the depth of the cellulose insulation (Figure

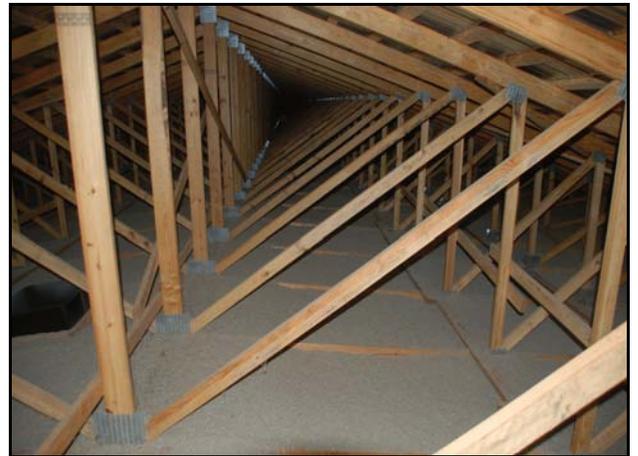
Figure 5. Blown cellulose (2 ½ years)

4) had decreased on average between 1" and 2" (Figure 5) and approximately 3" near the eaves compared to initial installation measurements. It is important to note that what appears to be settling near the eaves may be in part due to the movement of insulation caused by increased air velocities that generally occur in this area of the attic on windy days, and the fact that the original insulation depth was slightly less due to difficulties involved in blowing insulation near the eaves of a house. Bottom line, after 2 ½ years what was originally a ceiling with a R-value of 20 ft²*hr/Btu's (5 ½" blown cellulose) had decreased to a ceiling with a R-value of 15 ft²*hr/Btu's (4" blown cellulose).

The results of this field study indicate that for long-term insulating ability poultry producers may want to consider either stabilized fiberglass or fiberglass batts to insulate their dropped ceilings. If blown cellulose is used, producers may want to considering increasing the depth of insulation installed or plan on possibly adding insulation five to ten years post installation in order to keep heating costs to a minimum.

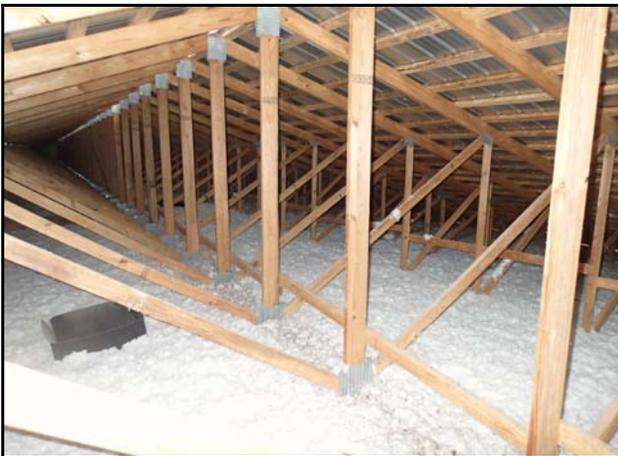
Figure 6. Blown stabilized fiberglass (7 years)

In November of 2015, approximately seven years post installation, the condition of insulation products was again evaluated (Figures 6,7,8, and 9). Though there was no appreciable change in the overall depth of the stabilized fiberglass insulation, there was further reduction in the depth of the blown cellulose insulation. Random measurements found that the depth of the cellulose insulation was to between 2 ½" and 3", roughly half the original depth. As observed during previous visits, the depth in some locations near the eaves was significantly less due to wind blowing into the attic at the eaves of the house. It was observed that there was a slight reduction in depth, approximately one inch, of the stabilized fiberglass insulation directly under the ridge likely due to rain occasionally being blown into the attic through the partially open ridge cap and wetting the insulation. There were no signs of either type of insulation moving away from the peak of ceiling.

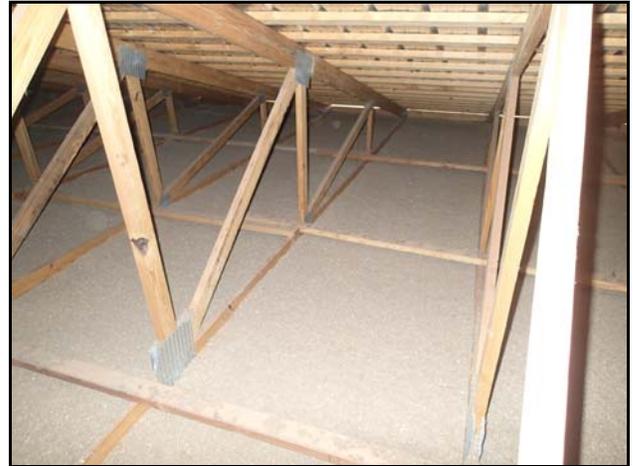
Figure 9. Blown cellulose insulation (7 years)

The results of this study to this point confirm the U.S. Department of Energy (DOE) recommendation that when using blown cellulose insulation, installers should take into account the fact that the insulation will settle. Whereas in typical residential installations, cellulose insulation is expected to settle 20% over time (compared to 2 to 4 percent for fiberglass) it appears that in poultry house applications cellulose insulation may settle 40 - 50%, over the long term resulting in roughly a 50% reduction in insulating ability. The increased settling observed in poultry houses is like due in part to the movement of “woven-poly” dropped ceilings as fans turn on and off. If a dropped ceiling is constructed of a rigid material (i.e., sheet metal, plywood) it is likely the settling would possibly be similar to that indicated by the DOE.
