Poultry Housing Tips

House Temperature Uniformity and Fan Maintenance

Volume 30 Number 4

2018

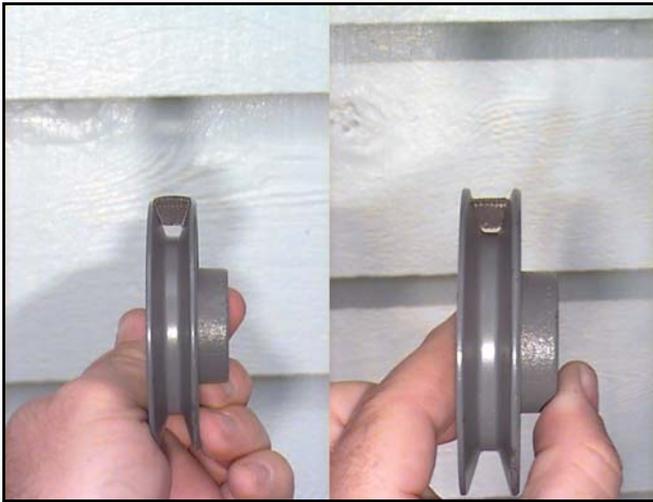
Figure 1. New belt and worn belt riding in a motor pulley.

There are primarily two causes for a fan not rotating at the proper speed: a worn fan belt, and/or a worn fan pulley. A fan belt is designed to ride on its sides in a pulley (Figure 1). As the belt wears, it becomes thinner, and as a result rides lower in the motor pulley. The lower the belt rides in a motor pulley the slower the fan blades will rotate and the less the amount of air moved. In addition, over time the belt moving over the fan motor pulley will cause the pulley to wear. As the pulley wears it acquires a slippery, mirror-like finish (Figure 2) and will become wider, acquire a more "U-shape" (Figure 3) instead of a proper "V-shape." The wider motor will cause even a brand new belt to ride too low in the motor pulley resulting in reduced fan prop speeds and air moving capacity.

A simple way to determine if a belt or pulley is worn through is by examining how the fan belt sits in the motor pulley. Generally speaking, the top of the fan belt should extend slightly above the edge of the fan motor pulley. If it is riding below the top of the motor pulley, either the belt and/or the motor pulley is worn and is in need of replacing.

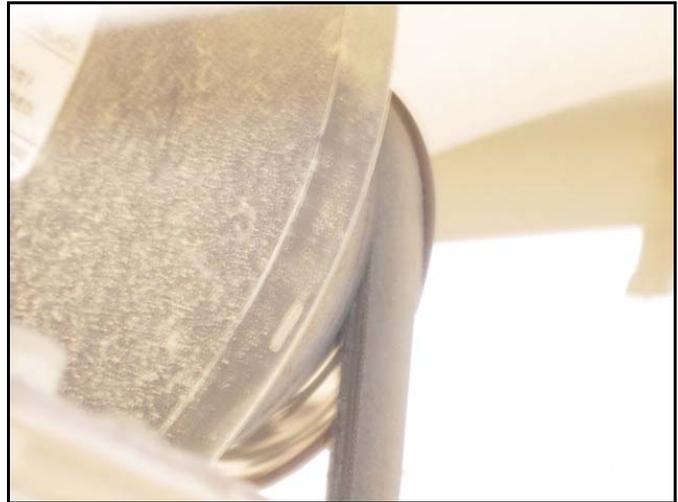
Figure 2. Worn fan belt and pulley.

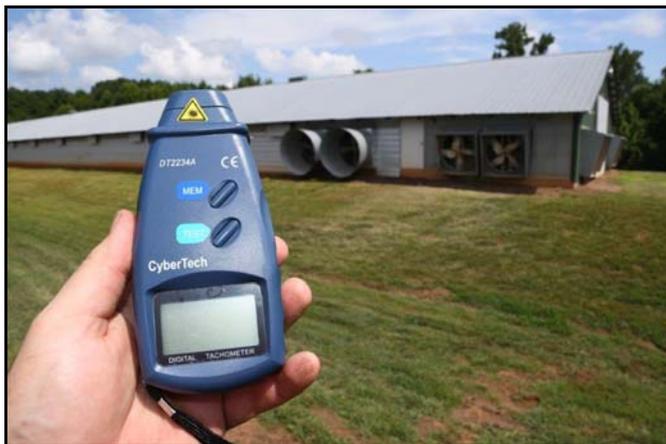
Figure 5. CyberTech DT2234A digital laser tachometer.

Figures 5 and 6 illustrate the use of one of the least expensive laser tachometers (CyberTech* - DT2234A). Standing inside the house, the laser tachometer is held approximately a foot from an open fan shutter, pointing half way between the motor and the fan orifice. The meter typically works best if it is not really bright outside and the meter is tilted slightly downward towards the ground outside the house. When the “test” button is pushed, a stable blade count reading is typically displayed within a few seconds. In this particular case, when the blade count reading of 1,818 is divided by the number of blades (four), it indicates the fan prop is spinning at a speed of 455 rpm (revolutions per minute). When the measured fan prop speed of 455 rpm is divided by the ideal prop speed of 474 rpm (Figure 7 - Fan performance test results published by University of Illinois Bess Laboratory) it can be determined that the fan speed is within 5% of the ideal and therefore the belt and pulley are in an acceptable condition. Had the reading indicated the fan speed was reduced more than five percent, the belt should have been replaced and the fan speed retested. If the fan speed were still too low it could mean that the fan motor pulley is worn and should be replaced. Typically, when this is the case, a visual check of the pulley will typically confirm that the pulley is in fact worn.

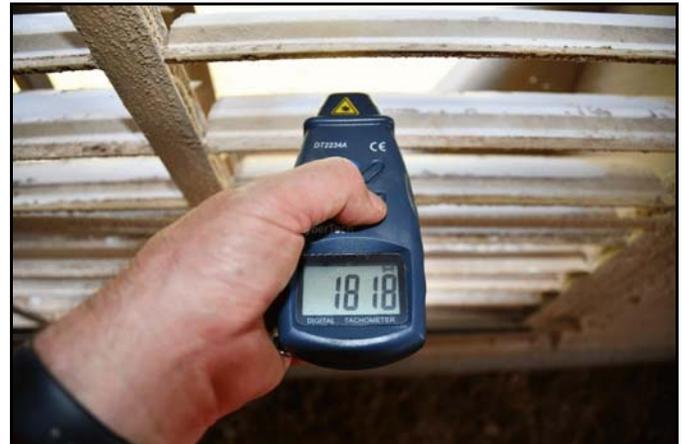
Figure 6. Using a laser tachometer to determine fan prop speed.
