Poultry Housing Tips

Insulated Tunnel Doors...A First Look

Volume 14 Number 10

December, 2002

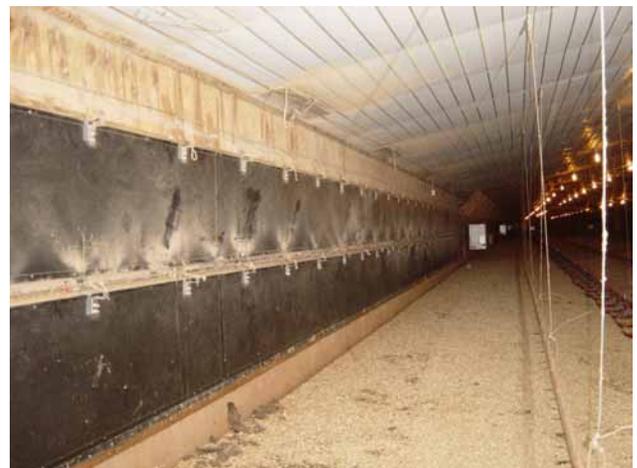
Figure 2. Insulated Tunnel Doors

To eliminate problems associated with poorly insulated and leaky tunnel curtains a new system has been developed and has been field tested for the last year on a broiler farm in North Georgia. The tunnel curtain (Figure 1) in the test house was replaced by a series of insulated doors manufactured by Canarm Ltd. (www.canarm.com). The doors measure eight feet by two feet and are constructed of two sheets of hard PVC plastic injected with one inch of polyurethane insulation (Figures 2 & 3). Each door has a continuous rubber hinge along the bottom and rubber gasket along the top that virtually eliminate any leakage. The doors have slot connectors on the sides that allow the doors to be slid together forming a continuous two-foot-high door down the length of the tunnel opening. To facilitate a four- or five-foot-tall pad, the doors are stacked one on top of the other.

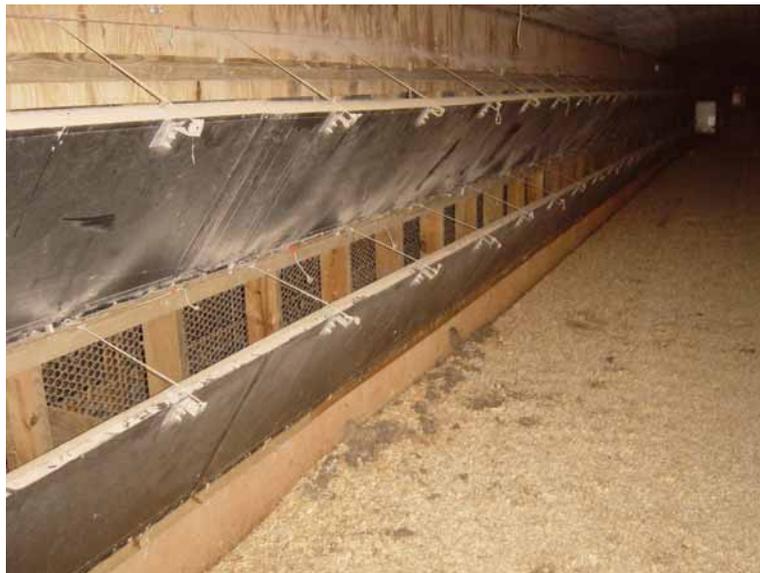
Figure 3. Partially Opened Tunnel Doors

The tunnel doors open and close much like most side wall inlets. A string is attached to a handle located every four to five feet along the top of the door and then connected to a cable through a small pulley. The cable is then connected to a standard inlet/curtain machine which opens the doors to about a 45 degree angle. Each eight-foot door is equipped with two latches which allow the doors to be closed extra tightly during cold weather, eliminating any possibility of leakage. During cold weather or when tunnel ventilating small birds, the bottom doors can be latched closed allowing only the top doors to open.

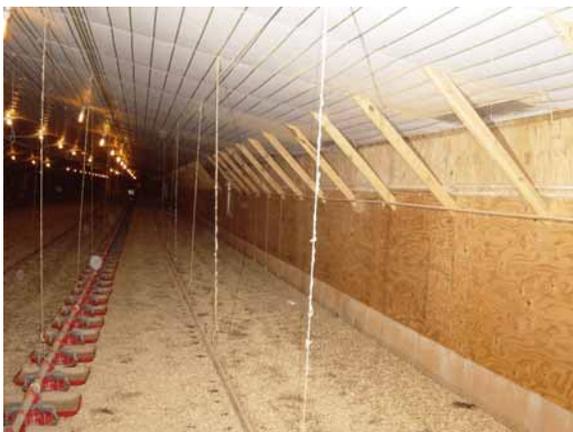
Figure 4. Northern Sidewall

The insulated tunnel doors were installed in a dropped ceiling 40' X 500' broiler house in February of 2002. The northern sidewall of the house is constructed of a sheet metal outside surface insulated with 3 ½" of fiberglass with a plywood interior (Figure 4). The southern sidewall is of similar construction but had a two-foot curtain (Figure 5). The house has 70 feet of four-foot-tall evaporative cooling pads on each side of the house, installed two feet from the side wall. The house is heated using radiant brooders in the brooding end, divided into three groups (zones), each of which is controlled independently by a modern electronic controller. An identical house, with the exception of the insulated tunnel doors, next to the test house was used for comparison purposes.
