# *Poultry Housing Tips*

## *Brooder Gas Hose Support Springs*

Volume 16 Number 1

January, 2004

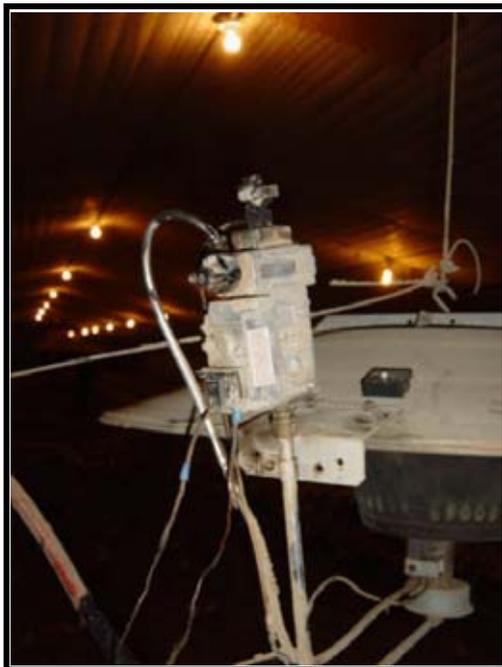
Figure 1. Fire caused by gas leakage where hose attaches to brooder

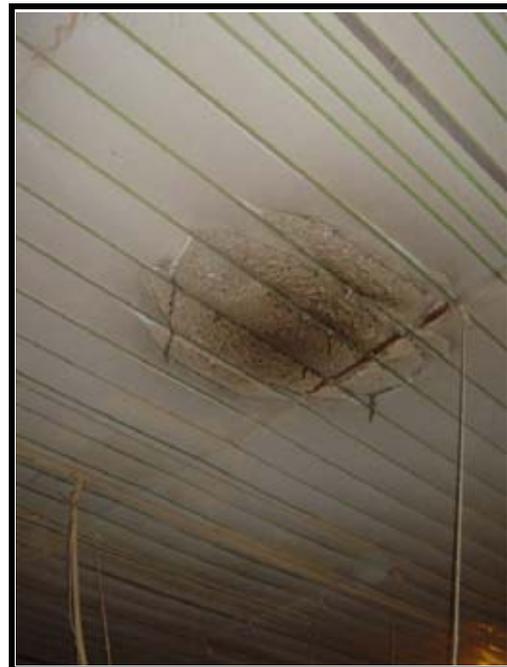
Figure 2. Ceiling fire damage

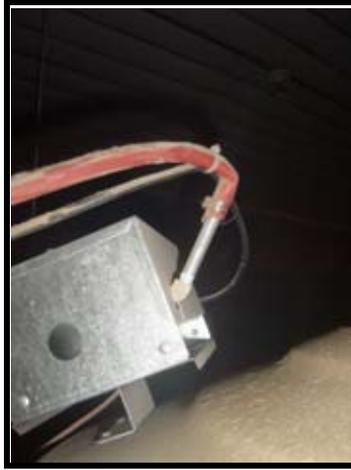
Figure 4. Pinched brooder gas line.

The pinching of the gas line is often the result of improper gas line/hose positioning and/or brooder movement. The lack of hose support at the control valve can allow the hose to pinch partially closed as the brooder is raised/lowered or moves. Though it is very important that gas hoses are properly positioned, sometimes it can be difficult to totally eliminate the hose flexing at the brooder.

A broiler producer in West Georgia came up with a simple and inexpensive method of providing flexible hose support at the brooder to minimize the possibility of gas hose pinching. The producer took a 30" X 3/32" welding rod (308 stainless steel) and wrapped it around a 1/2" pipe. The welding rod was used because though capable of being bent it retains some spring after being bent. After being bent the roughly 1/2" spring was pulled to a length of five to six inches. The ends of the wire snipped and bent so that they would not dig into the gas line.

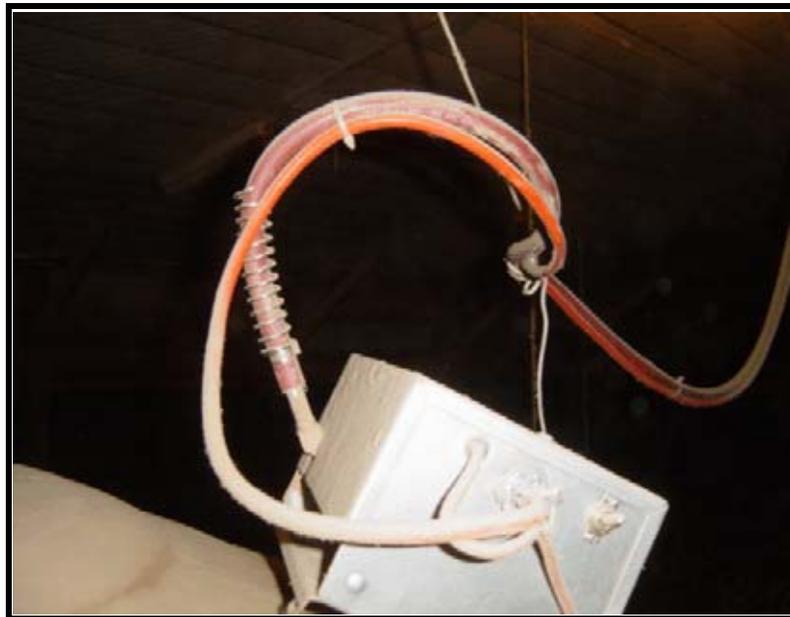
Gas flow was cut off to the brooders, gas hoses removed, and spring inserted over the end of the hose. The spring allowed the hose to flex but not to the point where it would pinch closed. Furthermore, the spring helps to keep the hose elevated off the brooder canopy reducing the likelihood of the hose touching the hot canopy.

Figure 5. Gas hose with support spring

It is important to note that if you are having hose pinching problems that you first review your brooder installation manual. The spring is intended to give the hose a little extra support but should not be viewed as a cure-all. It is very possible that the gas control box/valve was not installed properly, the gas hose was not lead to the brooder and/or supported according to manufacturer's recommendations, or the wrong type of hose was used. These issues should be addressed first before installing gas line support springs.
