## *Poultry Housing Tips*

*Simple Fixes Often Result in Substantial Fuel Savings*

Volume 22 Number 2

February, 2010

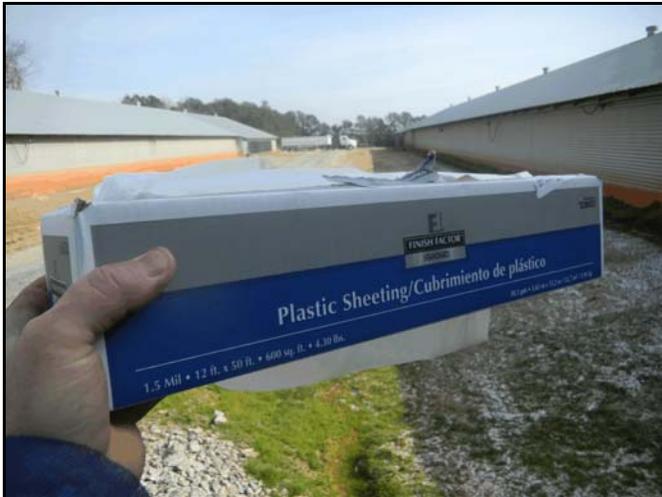
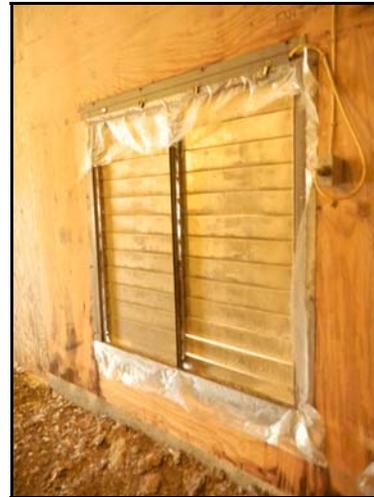
The good news for growers with tunnel fans with interior shutters is that there is a simple and inexpensive solution for this problem. Simply remove the fan shutter, place a piece of plastic sheeting on the exterior surface of the shutter (approximately one foot taller and wider than the fan shutter), and replace the shutter. Within seconds you will have virtually eliminated fan shutter leakage...at essentially no cost.

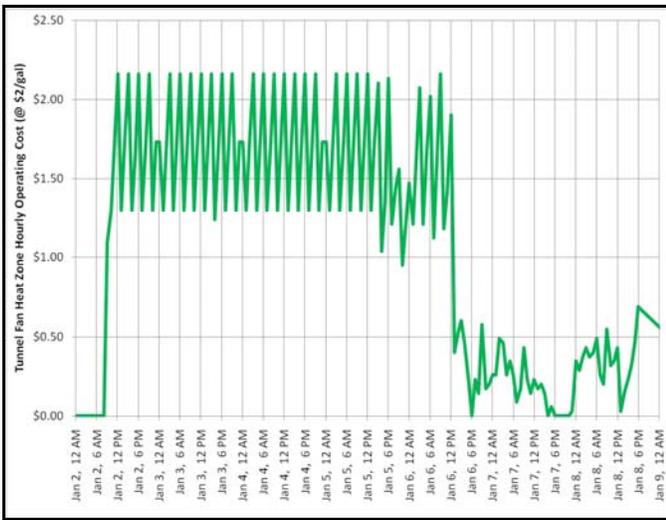
Figure 1. Tunnel fan heat zone hourly operating cost before and after installation of plastic sheeting on tunnel fan shutters (1:00 pm, January 6).

This simple fix can lead to fairly dramatic results. Recently on a farm near Athens, a producer was having problems with the radiant heaters nearest the tunnel fans running nearly constantly since he turned the birds out into full house three days prior. The house had solid side walls and was very tight other than the nine tunnel fan shutters. On January 6<sup>th</sup> at 1:00 pm a 6' X 6' sheet of 1.5 mil plastic sheeting was installed on seven of the house's nine 48" slant wall tunnel fans (the house's five 36" side wall exhaust fan shutters were not covered). Within minutes the air temperature near the tunnel fan end wall increased approximately seven degrees, and the radiant heaters shut off and only cycled on only occasionally (Figure 1).

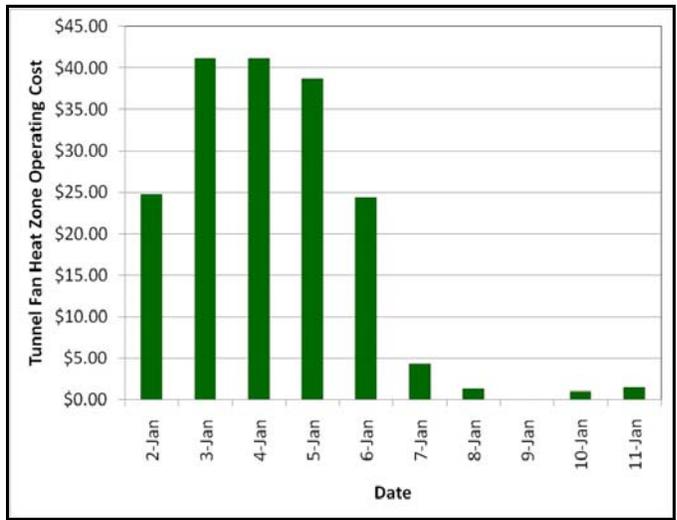
Figure 2. Daily tunnel fan heat zone operating cost before and after installation of plastic sheeting on tunnel fan shutters (@ propane cost of \$2.00/gallon).

After installing the plastic sheeting the daily operating cost of the radiant heaters near the tunnel end wall dropped to less than \$3 a day from approximately \$40 a day. Over the course of the next five days it is estimated that the \$5 worth of plastic sheeting installed saved well over \$100 in propane usage (Figure 2).

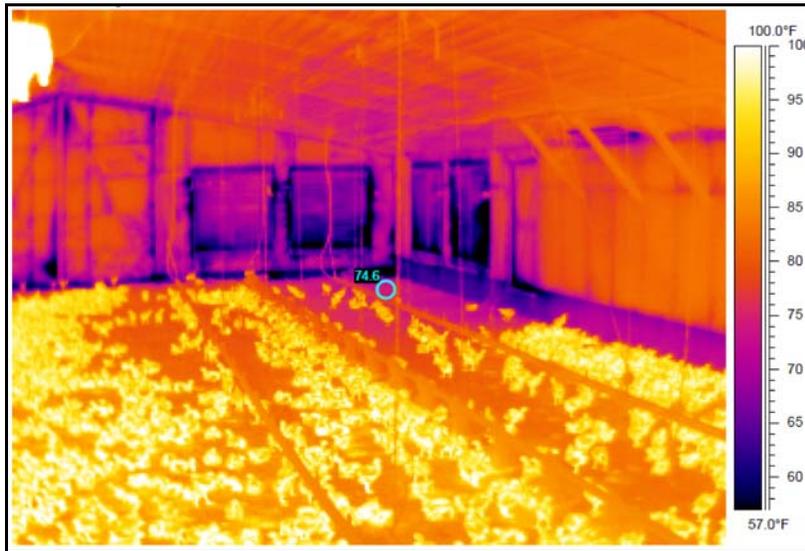
Figure 3. Thermal image of fan shutters with plastic sheeting.

Two days after the installation of the plastic sheeting, thermal images were taken of the tunnel fan area of the test house as well as an adjacent house where no plastic sheeting was installed on the tunnel fans (Figures 3 and 4). Floor temperatures near the tunnel fans were found to be nearly ten degrees warmer in the house where the tunnel fans were covered. In addition, bird surface temperatures in the last 40' of the house where the fans were covered, were noticeably higher than in the house with the uncovered tunnel fans.

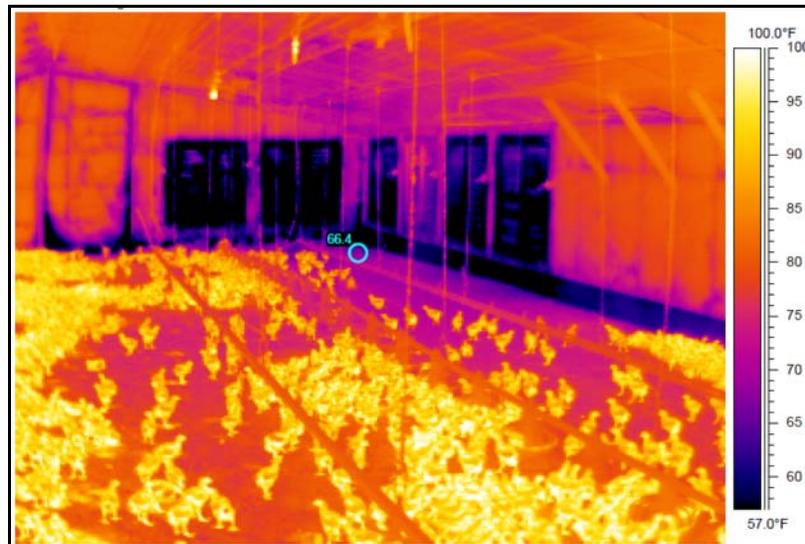
Figure 4. Thermal image of tunnel fans without plastic sheeting.

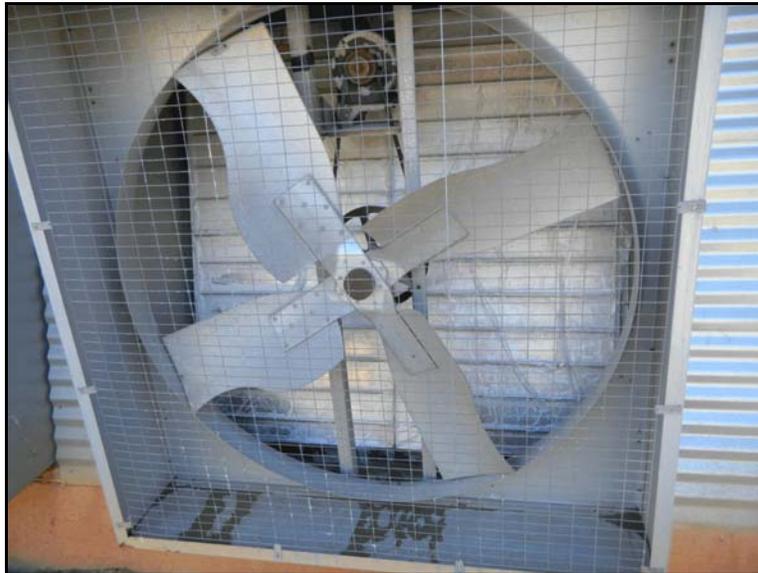
Figure 5. Condensation from covered fan shutter.

Though the plastic sheeting proved very effective, ideally some type of insulated fan cover would have been installed to reduce fan leakage. The primary reason for this is to reduce formation of condensation on the fan shutters (Figure 5). During very cold weather the condensation which forms on the plastic sheeting and the shutters can turn into ice around the edges of the fan thus reducing the tightness of the plastic. Furthermore, condensation can run down the walls damaging side wall lumber and insulation as well as causing some limited litter caking. A proper insulated fan cover would not only solve the leakage problem but the condensation related problems as well.
